NRE No. 1 Colliery, Russell Vale: Conservation Management Plan

FINAL

Prepared for Gujarat NRE Coking Coal Limited

27 February 2013

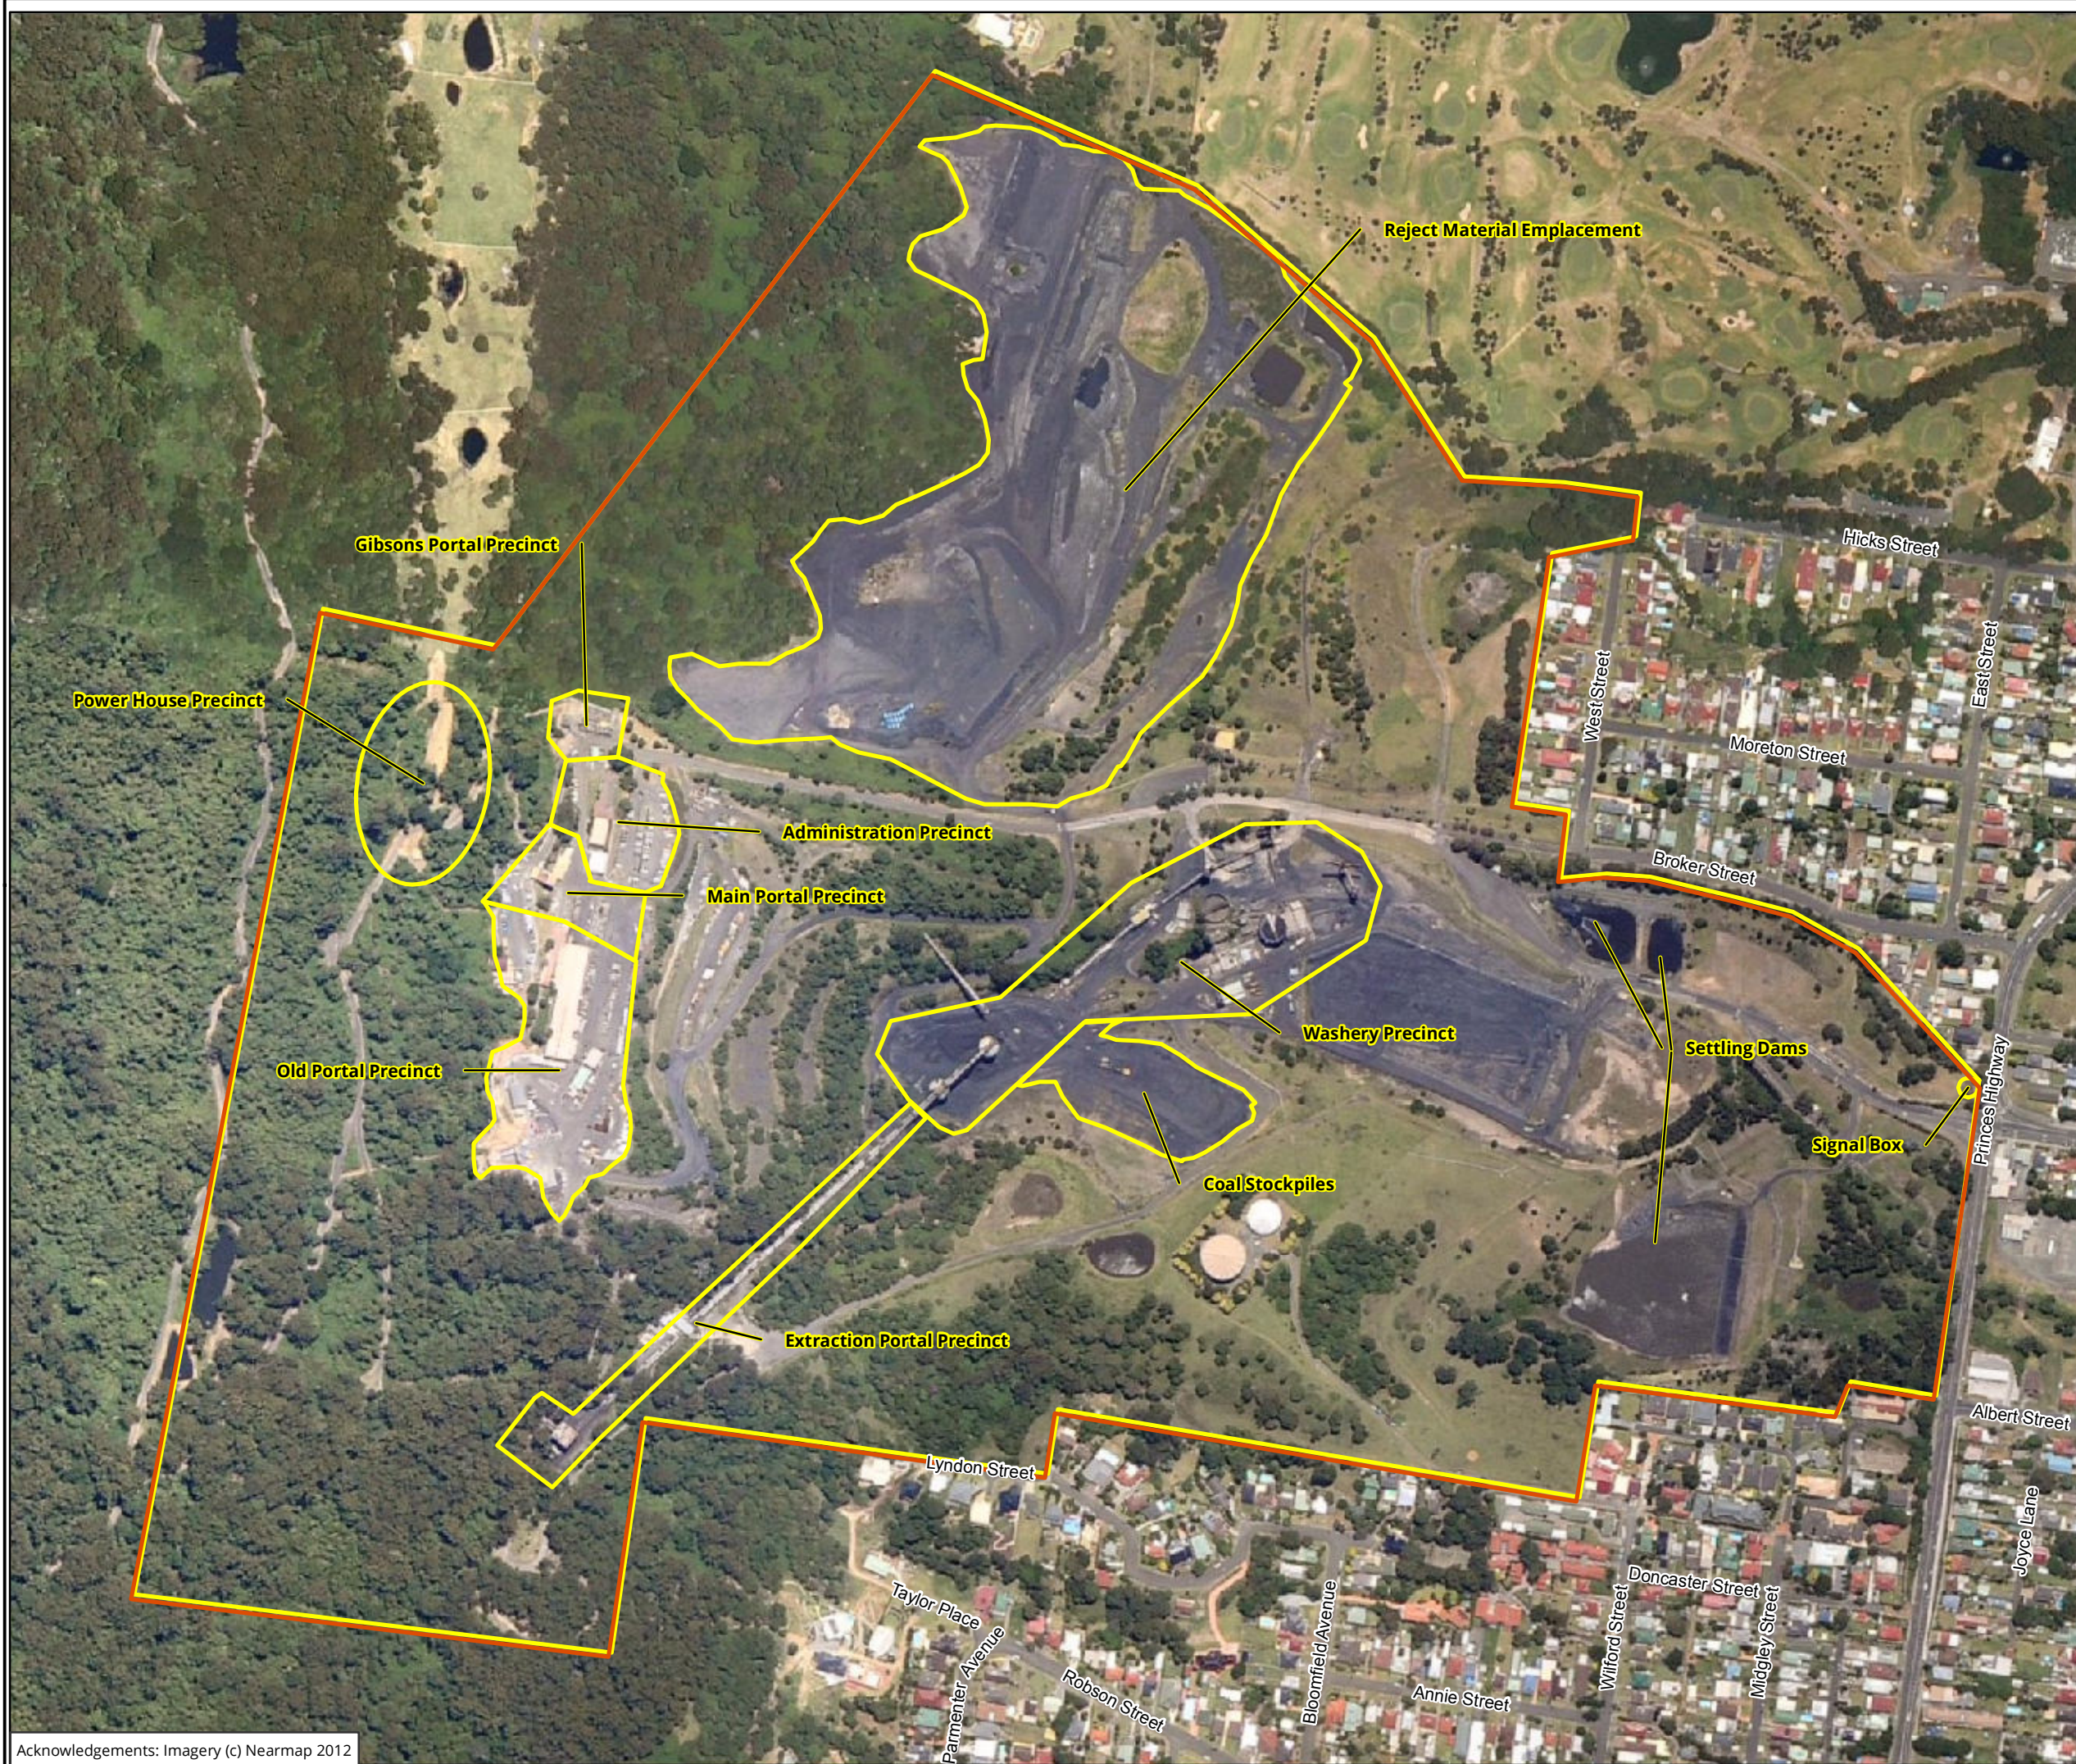
Figure 2: Precinct Plan of the Project Area

The locations of the mine areas are shown in Figure 2 and the detailed layout of the features is shown in Figure 4. A description of the precincts and their associated site elements is provided following. These descriptions have been updated based on the results of the 2011 site visits by Biosis particularly in regards to changes in condition or removal of specific elements.

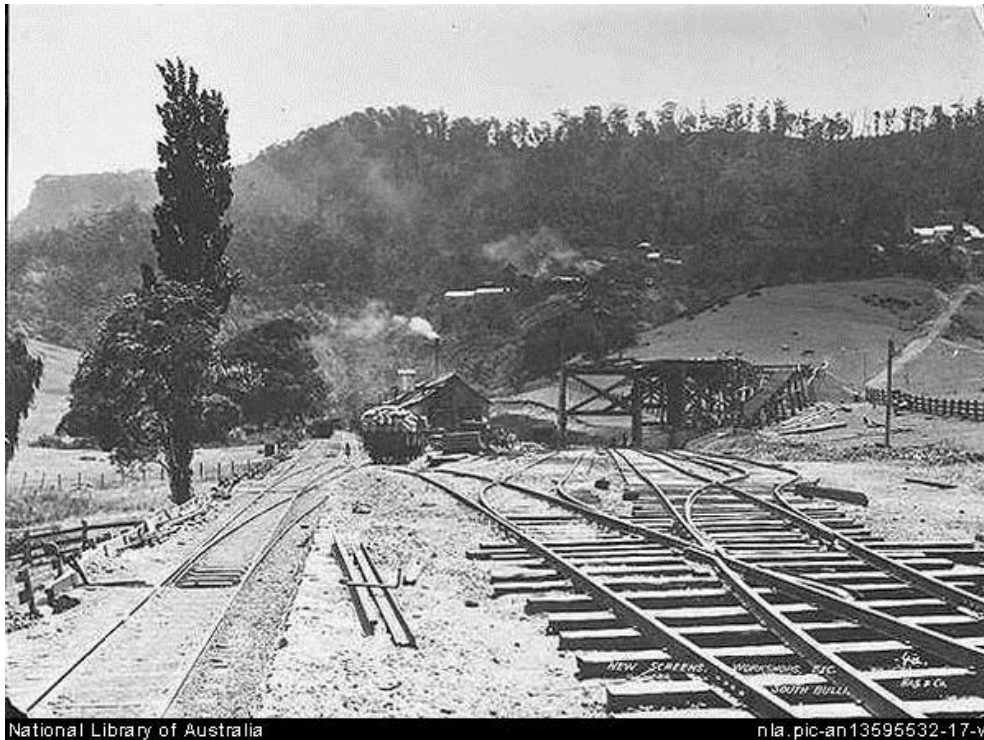
Plate 7: New screens, workshops, etc., South Bulli ca. 1906. National Library nla.pic-an13595532-17 PIC P694/1-47 LOC Album 918

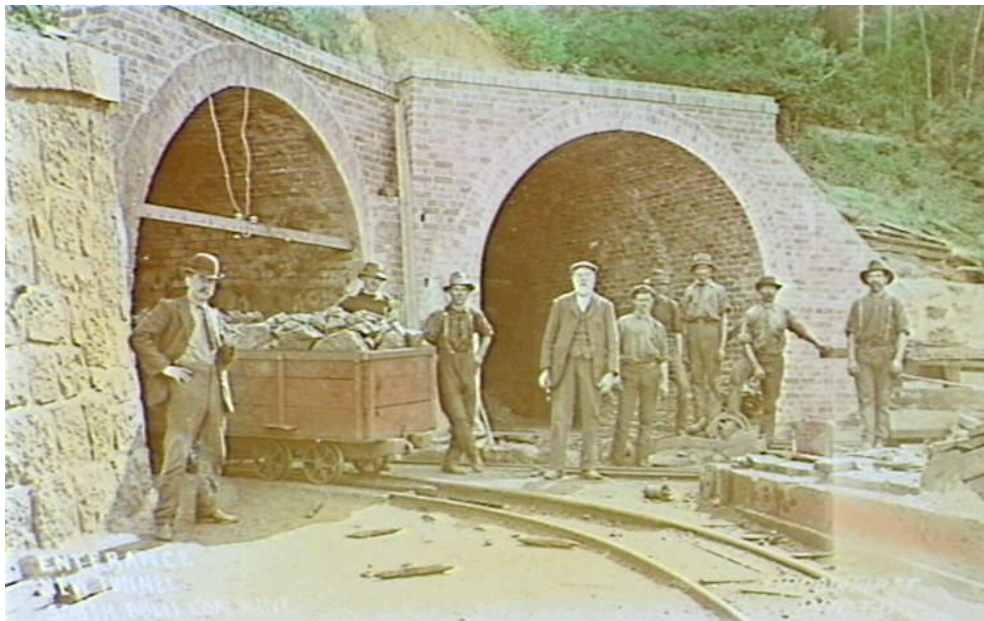
The Russel Vale estate was also broken up in two large land sales in 1904, many of which were bought by miners and their families (Russell Vale Local History Group 1994). A power station for the mine was built in 1913 above Gibson's Portal which also supplied the Bulli Township until 1957 (GML 2004: 12). Electrical lighting was installed underground and the mine was operating both day and night (Bayley 2002: 10). The demand for coke increased at the beginning of the 20th Century, and coking ovens were installed along the

Plate 8: Gibson's Portal 1915. Wollongong City Library P02/P02407 Broadhurst Photos

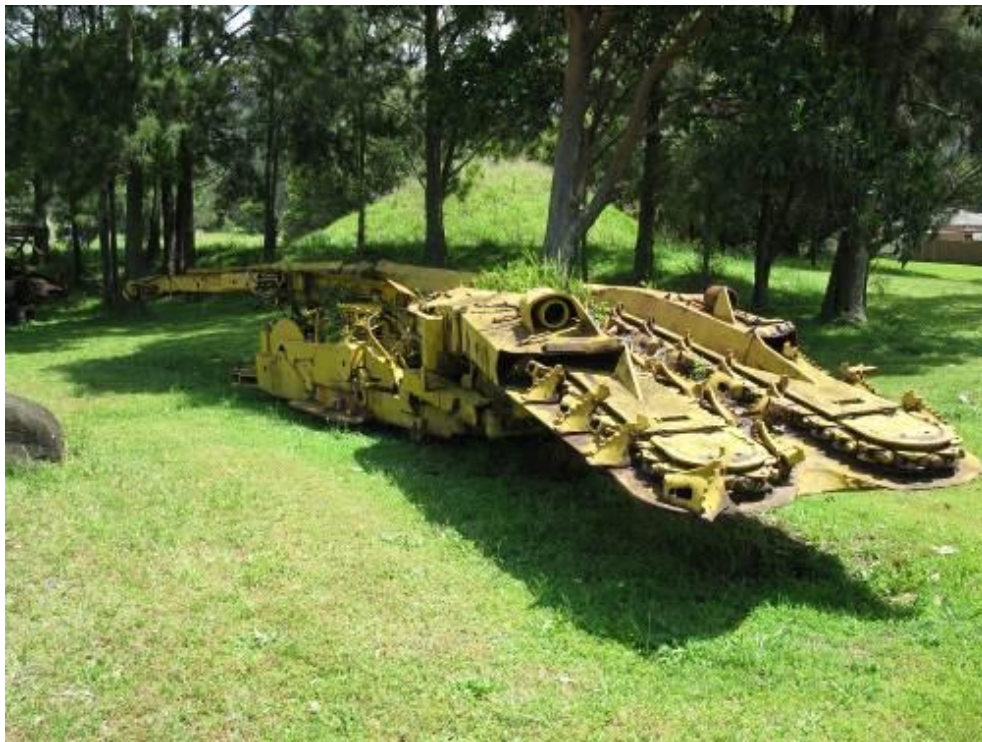
Mechanisation of the South Bulli Colliery began in 1935 with the introduction of an arcwall cutter, with a second cutter being introduced a year later (Austen and Butta 1991: 3, Plate 10). The arcwall cutters were CA12 type cutters mounted on tracks and replaced hand mining on the face (GML 2004: 13). Improvements to the ventilation and underground transport system continued in the early 1940s Two D type scrapper loaders were introduced in 1947 and four Maver and Coulson loading Machines were installed in 1949, greatly increasing productivity (Austen and Butta 1991: 3). The scrapper loaders were replaced in 1954 by a track mounted L600 loading machine, 20U mechanised cutter and two electric battery locomotives of Jeffery manufacture (Austen and Butta 1991: 3).

Plate 10: Short-wall Coal Cutter 2011. Biosis.

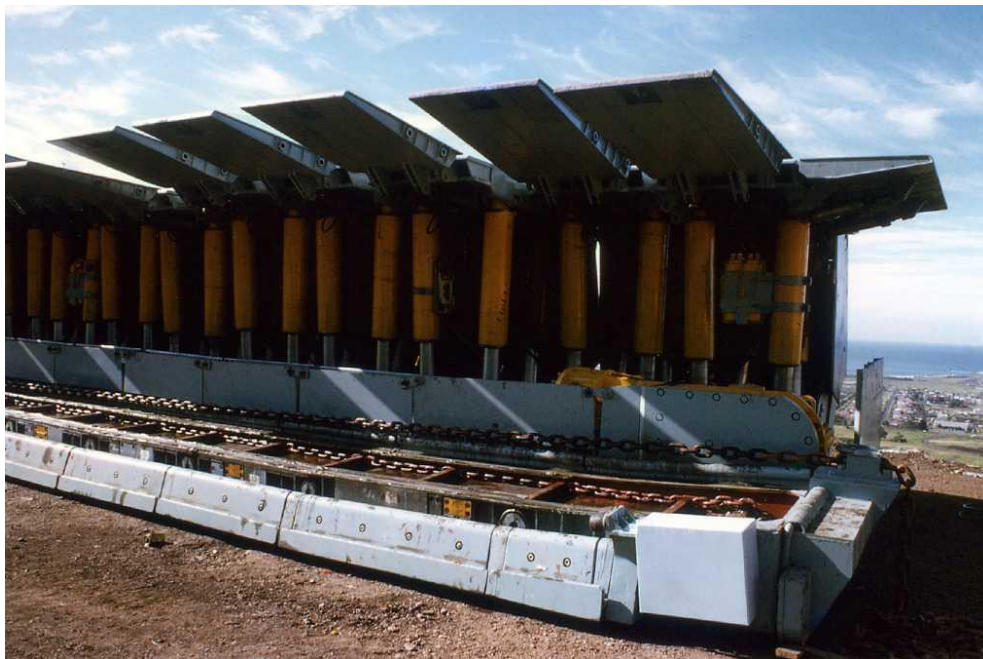
New office building and lower work sheds were officially opened in 1965 by Sir George Harvie-Watt in 1965 (Australian Coal Association 1965: 22). During the mid to late 1960s longwall mining in Australia was pioneered at the South Bulli Colliery. Specialist equipment was commissioned in 1965 consisting of Gillick chocks, Mecro face conveyor and Anderson Berghs coal shearer (Austen and Butta 1991: 4). A second longwall unit was installed in 1970, but it was not until a new Japanese system from Taiheyo Engineering Incorporated was introduced in 1975 that the process had significant outcomes (Austen and Butta 1991, Plate 12).

Plate 12: Japanese Taiheyo Engineering Incorporated Super Dynamic SD System 1975. Wollongong City Library P19/P19253.

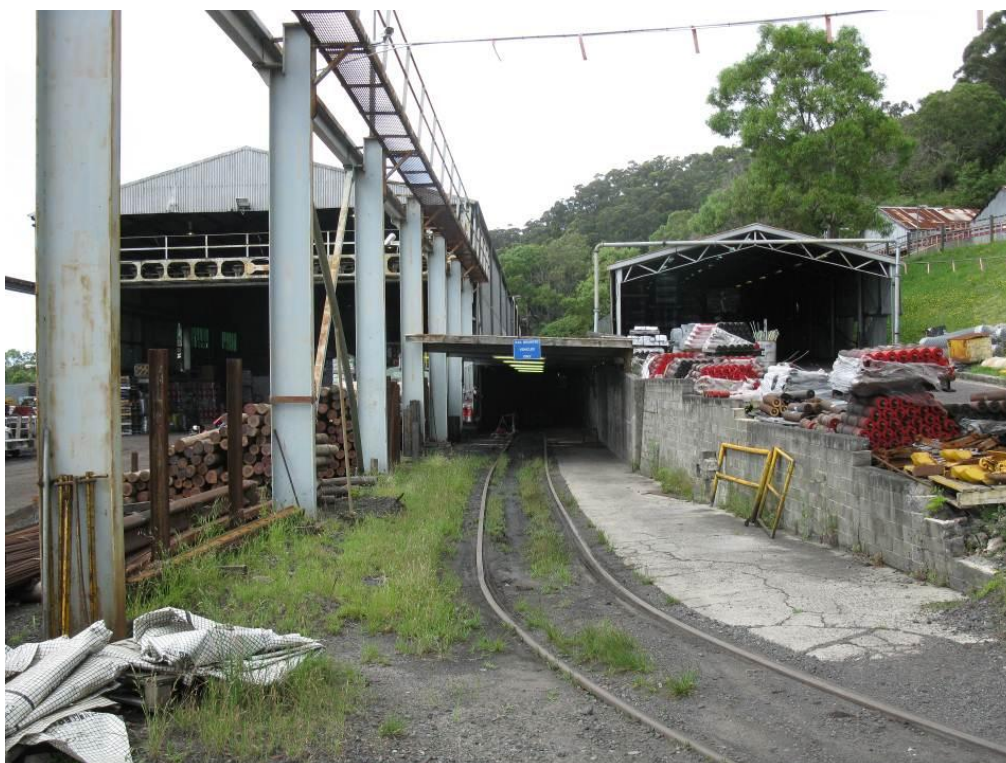
Plate 14: Main Workshop (left) and Diesel Shelter (right) looking south. 2011 Biosis

The lower bench workshops are actively in use and are in good condition.

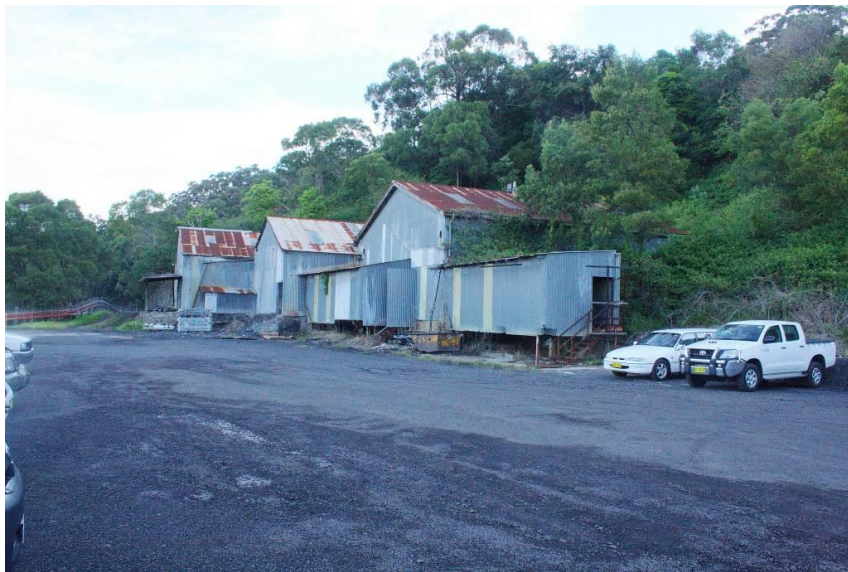
Plate 15: Upper Bench Workshops 2011 Biosis

The upper bench workshops consists of the carpenter and locomotive workshops, with the workshop offices contained to the rear of these workshops on an elevated bench reflecting the joint functions of the building (**Error! Reference source not found.**). The workshops consist of steel-framed corrugated iron clad sheds with three gable roofs. The sheds are all interconnected with no interior partitioning (**Error! Reference source not found.**). The workshops appear to have been adapted to several functions, and retain track work related to both the underground workings, and probably from use of the buildings as rail vehicle maintenance facilities.

The upper bench workshops are no longer operational and the workshops are used primarily for storage. Vegetation has been pruned back since the 2004 GML assessment, however large areas remain overgrown. As recorded by GML the roof of the workshop offices has collapsed and timber structures have degraded. Brick, steel and concrete structures remain in fair condition. The upper bench workshops remain in fair to poor condition as assessed by GML in 2004.

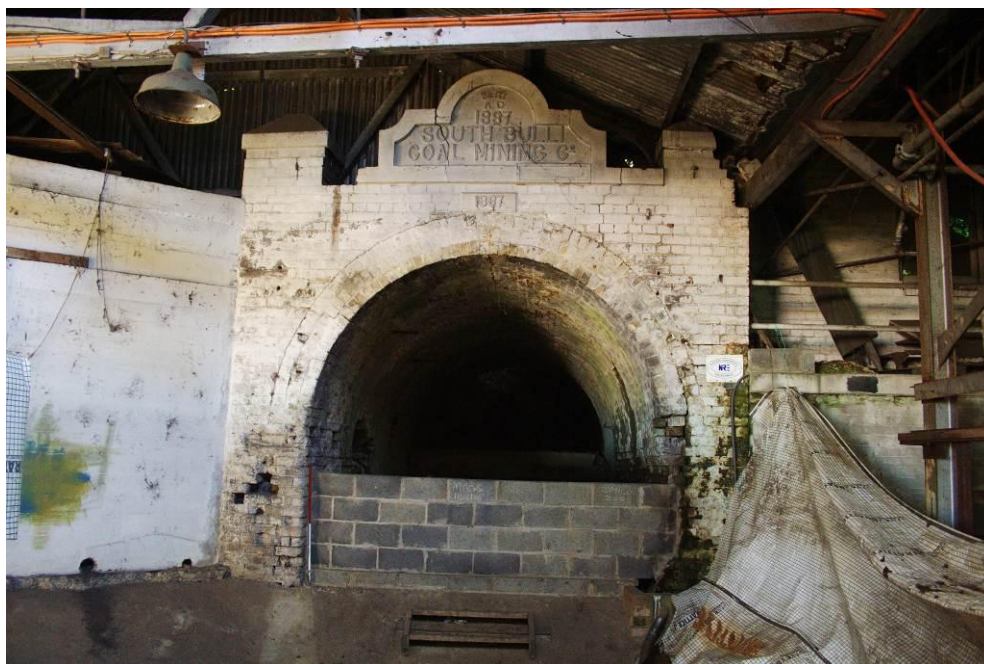
Plate 17: 1887 Portal 2011 Biosis

Now located inside the Carpenters and Locomotive workshops, the 1887 Portal is one of a pair of semi-circular arched brick lined adit entrances (**Error! Reference source not found.**). The second portal to the outh (left) of the 1887 Portal is shown in the earliest photographs (Plate 18), but was much shorter in length than the 1887 Portal. Now bricked over, this portal is referred to as the “Old Man’s Hole” as it was used by older miners to mine coal to sell on the local market. Before pensions were introduced, this allowed older miners to support themselves once they were no longer able to work on the main face (personal communication Don Jeffcott, former Gujarat NRE Employee). A brick retaining wall curves east and then south from the 1887 Portal and “Old Man’s Hole”, which is also visible in early photographs of the 1887 Portal (Plate 18 and Plate 19). There is an additional adit located behind the workshops and north of the office buildings, it has been bricked off with concrete blocks. To control water drainage issues with the 1887 Portal, three concrete block walls and drainage channels have been installed (**Error! Reference source not found.**).

The 2004 GML assessment recorded the 1887 Portal and other adits as in intact and fair condition although some dilapidation was noted (GML 2004: 49). The retaining wall was recorded as being in poor condition with cracking and bulging of the brickwork (GML 2004: 50). The current assessment did not observe any further deterioration of the precinct.

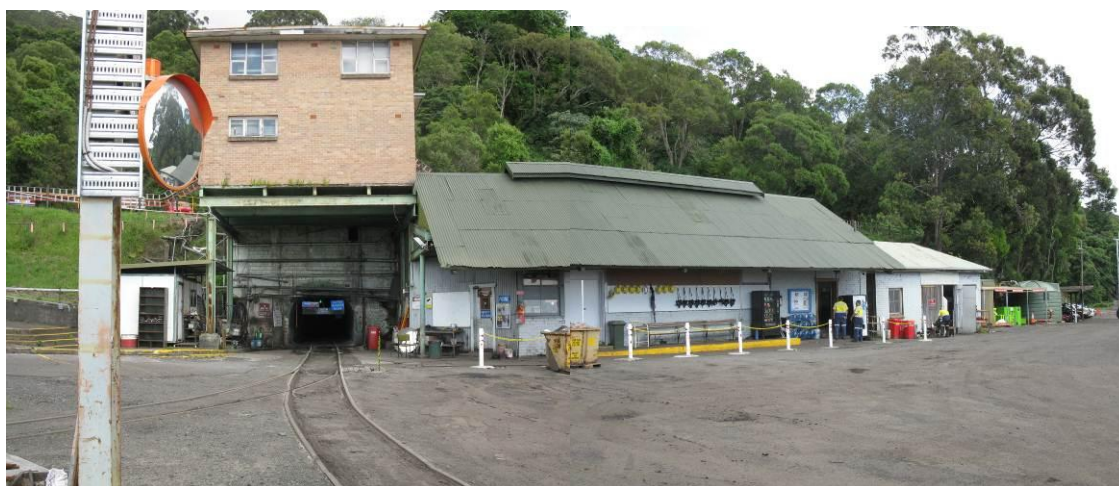
The Main Portal Precinct consists of the Main Portal, new bathhouse, crib, first aid rooms and storeroom, which are clustered on the lower bench (Plate 20). The Main Portal appears to date from the mid 20th century and with the adjacent new bathhouse, crib room, etc. helps interpret the dramatic expansion of mining on the site in the second part of the 20th century. The location of the building directly over the portal entrance is highly unusual, and reflects the particular difficulties of utilising all available space for construction on the steep Illawarra escarpment site, which is a special characteristic of the Wollongong region mines. The style of the crib room/lamp room is also indicative of mid 20th century construction, and so like the upper bench workshops, the buildings demonstrate a critical period in the mine's history.

Plate 20: Left to right – main portal, new bathroom above, crib room, first aid station (former Lamp room) store room. 2011 Biosis.

Some maintenance work has been carried out to buildings within the Main Portal Precinct since the 2004 GML assessment, including repainting, the installation of bollards, new signage and the addition of demountable buildings. The Main Portal Precinct is in active use and is in fair condition.

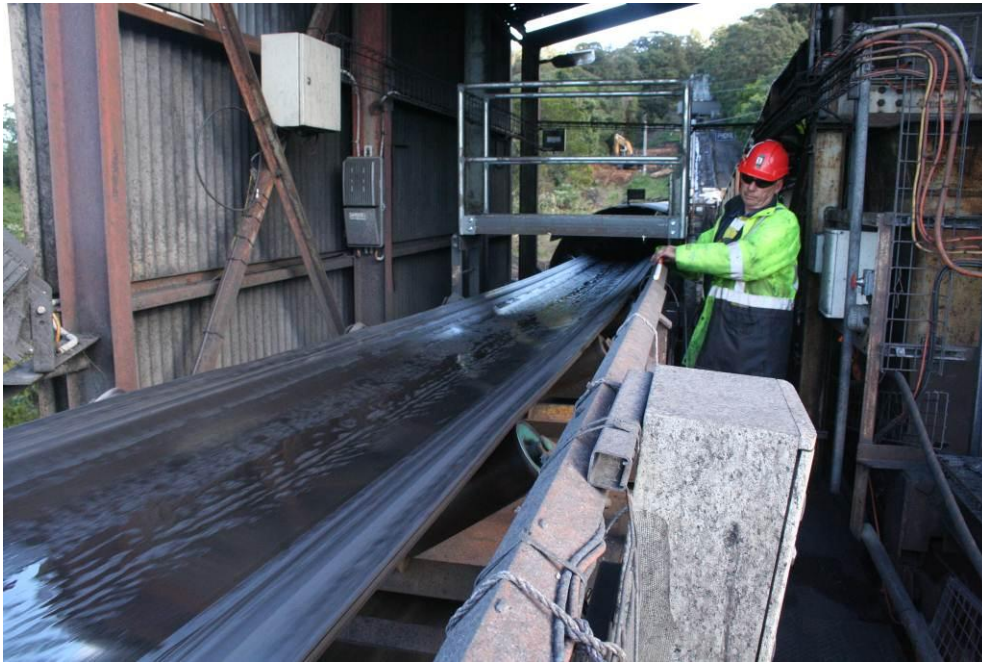
The group of structures within the Extraction Portal Precinct relate to the 1960s mechanised mining operations and include the Extraction Portal, decline conveyor and closed adits. The Extraction Portal is a steel and corrugated iron structure located approximately 1 km south of the Main Portal. The decline conveyor runs from the Extraction Portal to the coal storage bins in the Washery Precinct (Plate 21). The 2004 GML assessment identified two closed adits within the Precinct, but an unknown number of “lost” adits are also present.

Plate 21: Looking up along the decline conveyor from Coal Storage Bin 1. 2011 Biosis.

The Extraction Portal Precinct is currently in use and although some operational maintenance has been undertaken the fabric recorded by GML in 2004 remains largely intact and is in fair condition.

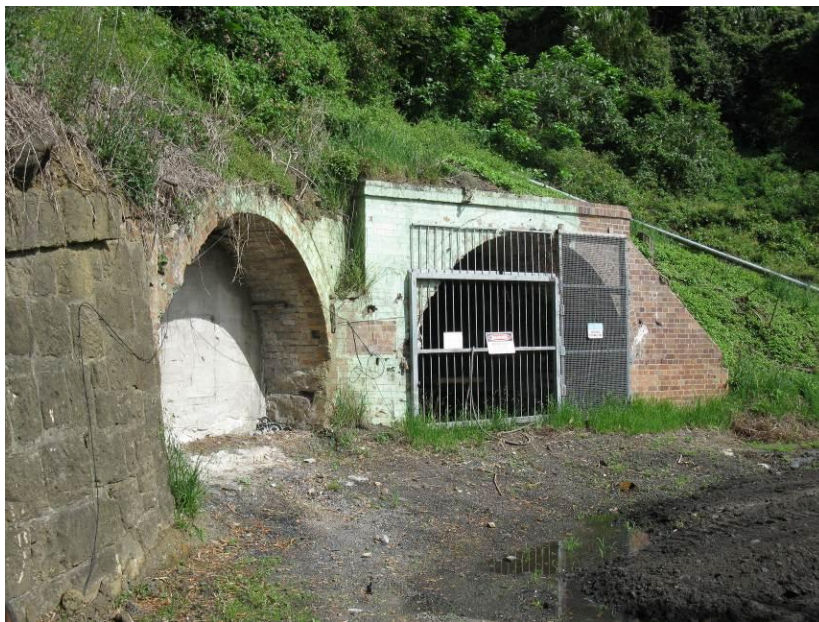
Plate 22: Gibson's Portal 2011 Biosis.

This group of structures are primarily of value for the remaining twin portals (Gibson's Portal is either one or both portal) which like the 1887 portal has only been identified in previous studies in the singular. Since the 2004 GML assessment the fan house has been demolished and one adit opened with new grating installed over the entrance. Vegetation in the Precinct has also been cleared to allow operations to take place (**Error! eference source not found.**). The portals and sandstone retaining wall remain largely intact to their original condition although their height of the portal entrances have been reduced due to either the build up or placement of fill at their base (compare **Error! Reference source not found.** with **Error! Reference source not found.** from 1915).

While some elements from the Gibson's Portal Precinct have been removed, these were intrusive and the significant elements remain in good condition.

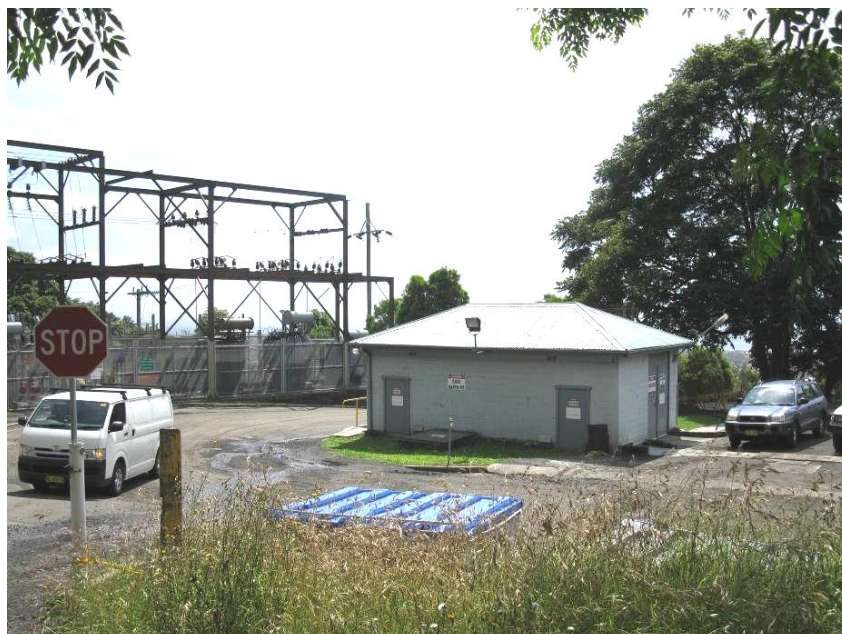
The concrete block fan house (now removed) and the substation/switchyard is of minimal significance. A small electrical switchroom probably from mid 20th century contributes to the more consistent built character of the upper bench (Plate 23).

Plate 23: Electric switch room with switchyard to left rear. 2011 Biosis.**Condition**

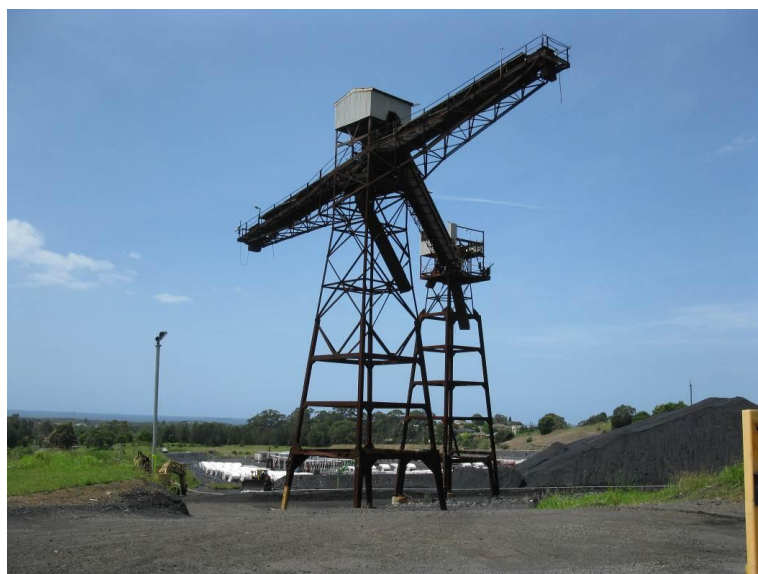
Plate 24: Remnants of coal gantries, 2011 Biosis.

The Old Washery was constructed in the 1960s and included a large steel framed corrugated iron clad Preparation Plant, conveyer system (part of the decline conveyer), concrete coal storage bins and a truck loader. The remnant structures from the 1960s (Plate 24 and Plate 25) are among the only elements which convey the major processing activities on the site during that period. Most of the 1960s have been demolished and the remainder of any standing fabric will be demolished in due course under existing planning approvals and permits as part of upgrades to existing operations. It is understood that archival recording and analysis of these structures have been undertaken by Paul Reinberger as a permit condition.

While the Washery Precinct elements that remain are in fair condition, they are scheduled to be removed.

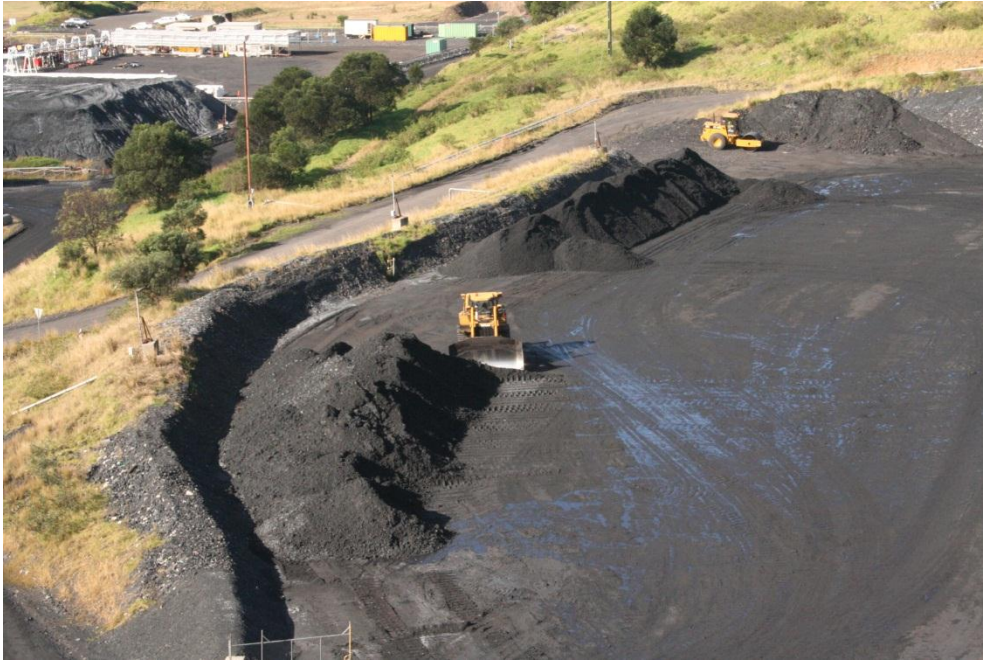
Stockpile and landfill areas generally consist of active landscaping works and do not have readily identifiable fabric elements. Dams also consist mainly of landscaping works, although some brick, concrete and metal pipe fabric does exist. Dams within the site are still in use and in fair condition.

Plate 26: Coal stockpile area south of the coal storage bins. 2011 Biosis.

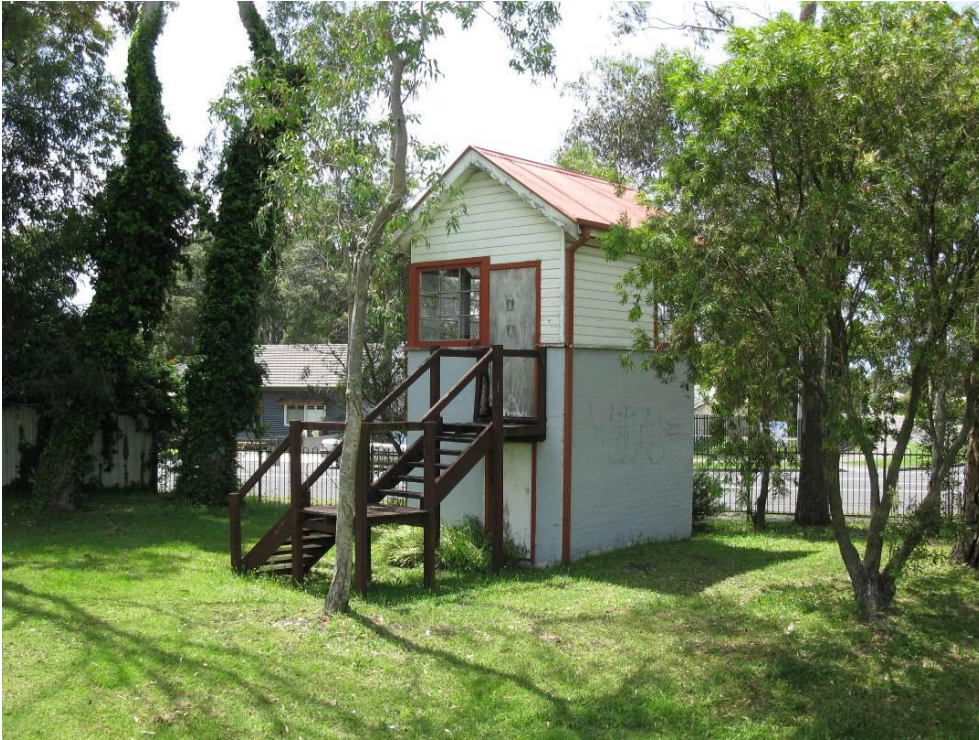
Plate 27: Restored signal box, 2011 Biosis.

Most rail track has been removed and the visible remains are in poor condition. The signal box remains intact and is in good condition.

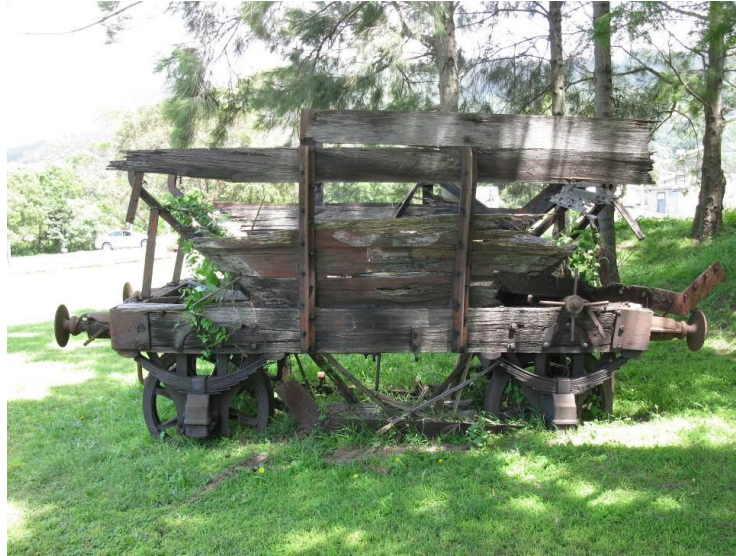
Plate 28: Coal wagon. 2011 Biosis.

GML recorded that historical mining equipment was put in an open air display in conjunction with the restoration of the signal box in 1988. The display included a steel framed timber-sided hopper wagon (a coal wagon type commonly used in the 20th Century) and a short wall coal cutter (**Error! Reference source not found.** and Plate 28).

These items of portable heritage are placed near the mine entrance for display purposes. While the coal cutter looks reasonably intact it is subject to severe corrosion. The coal wagon has deteriorated substantially since first photographed and is at risk of losing all its timber and is suffering metal corrosion. It would appear that the wagon was originally one of three retained and/or displayed to reflect the evolution of coal wagons at the mine.

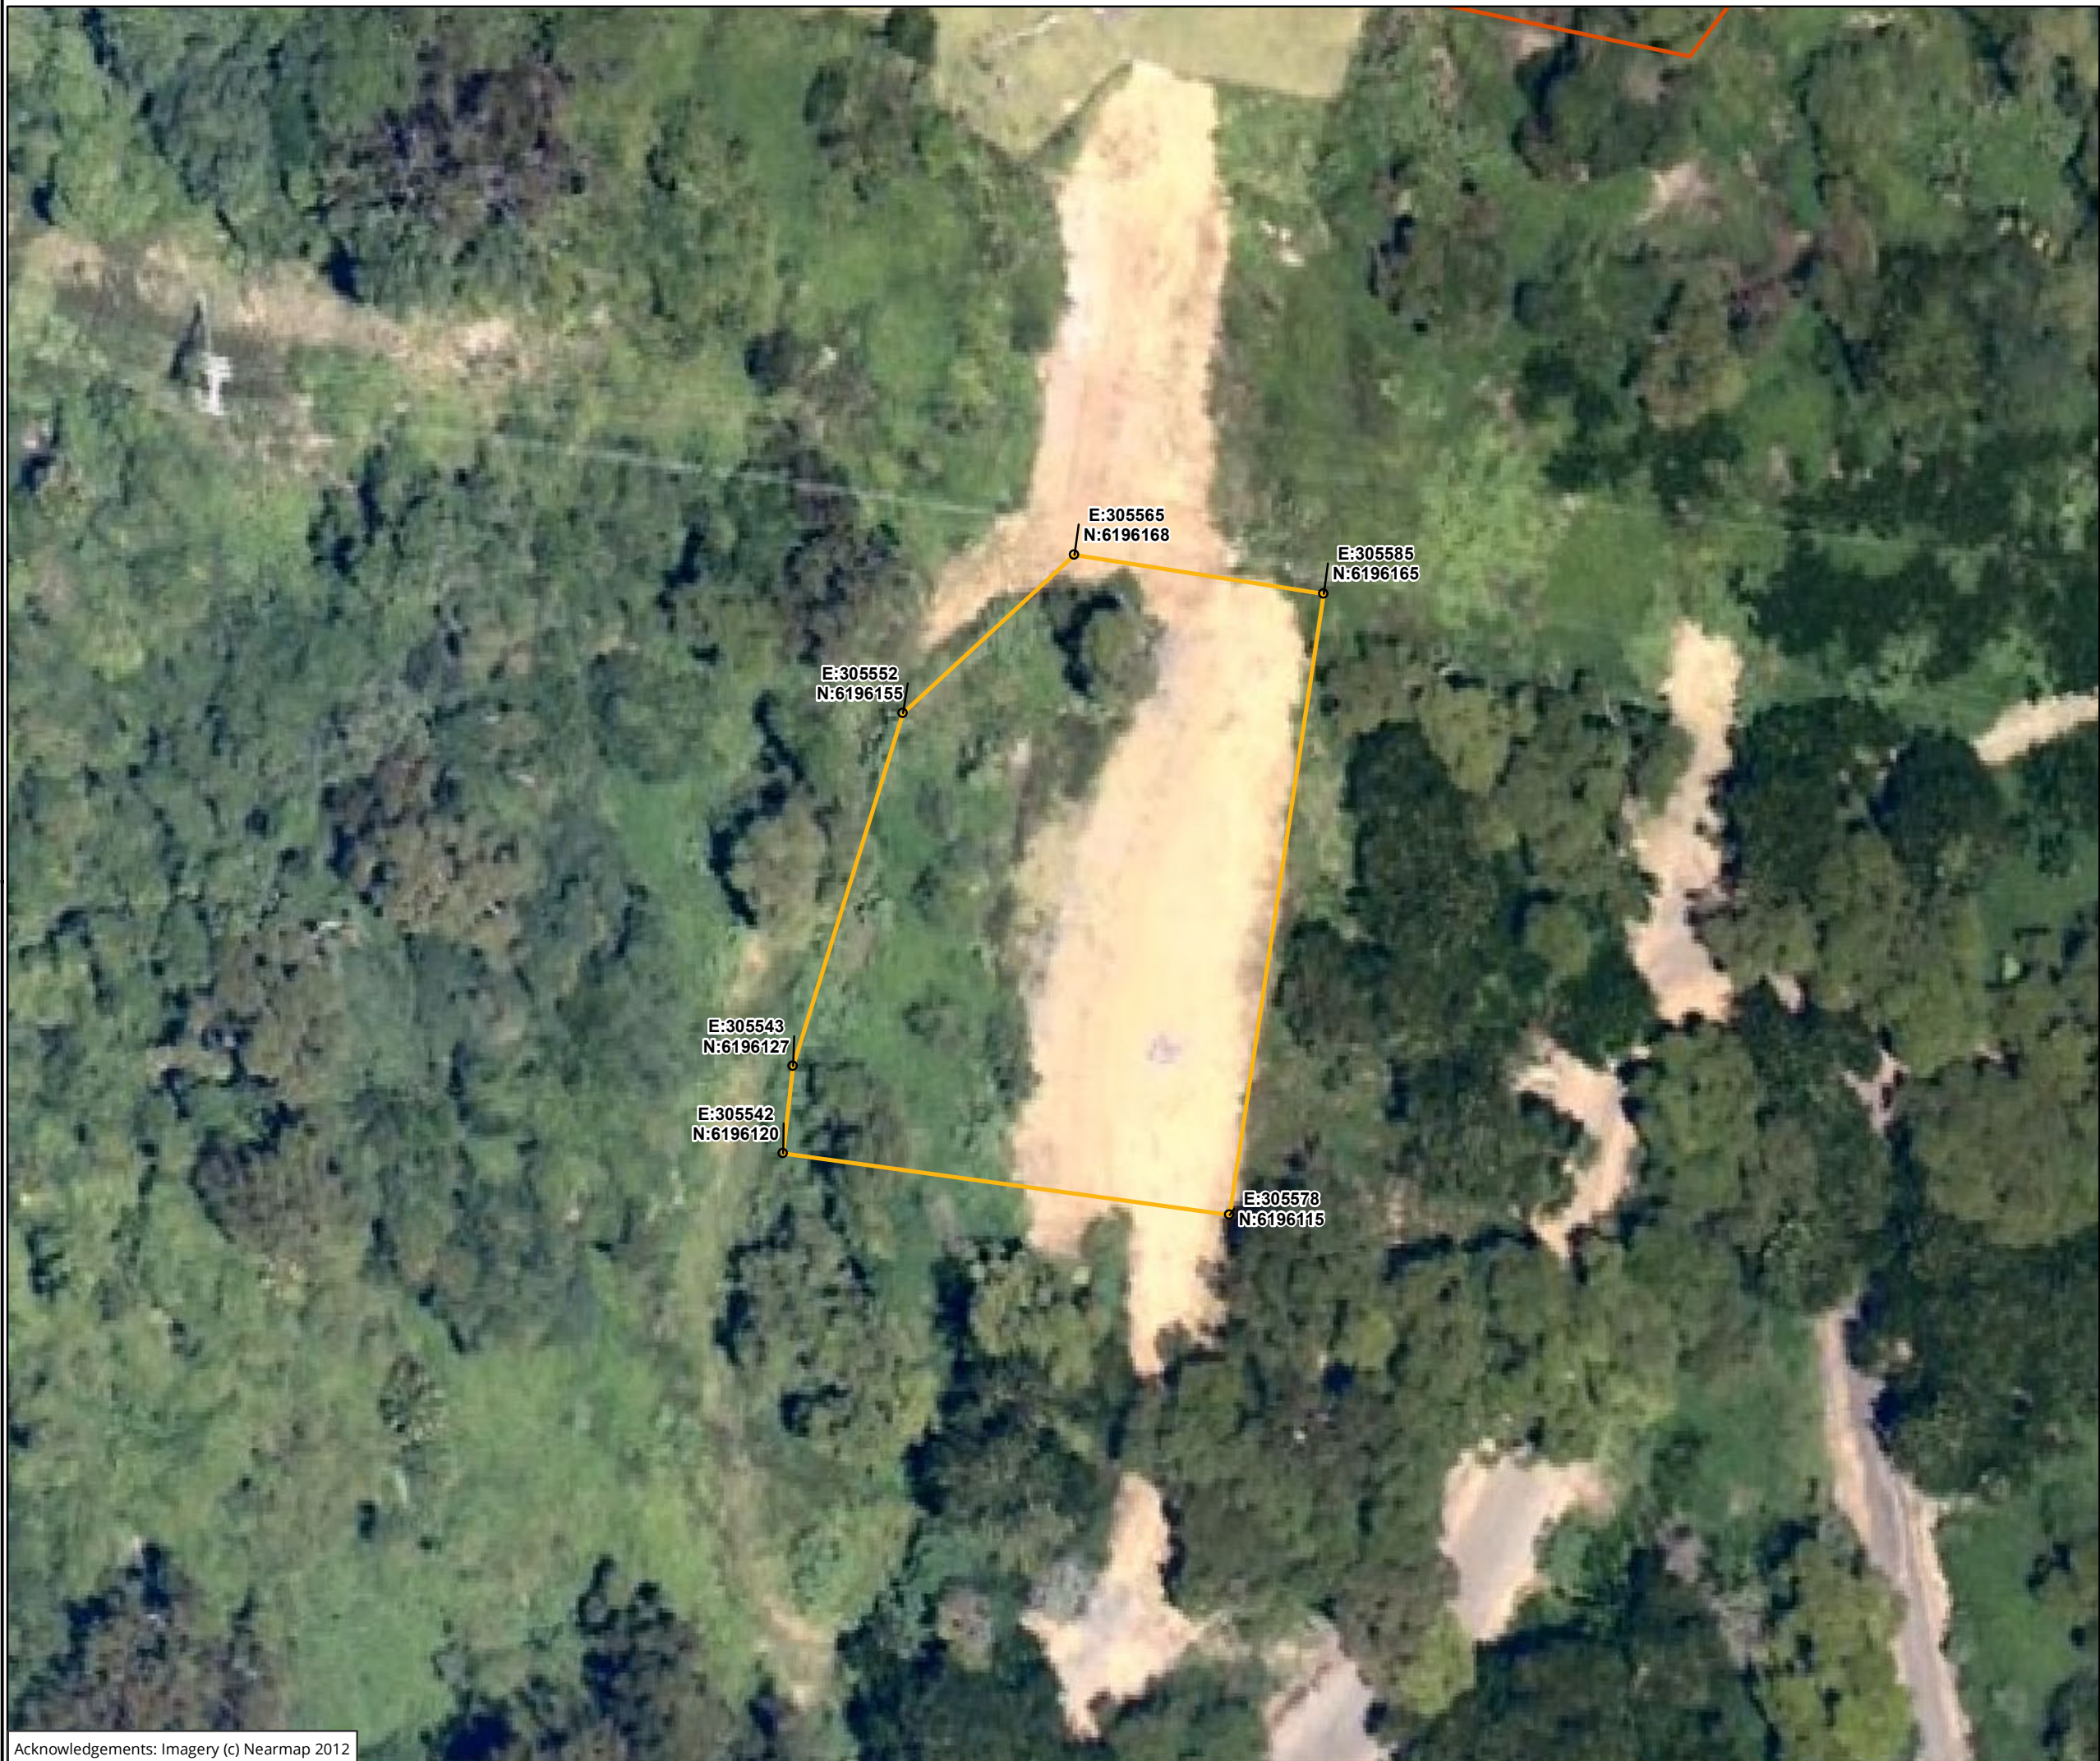
**Figure 5: Power House
Precinct Curtilage**

The Power House Precinct curtilage is shown in Figure 5 and includes all the remaining footings and features remaining from the power house and its associated elements.
