NRE No. 1 Colliery, Russell Vale: Conservation Management Plan

FINAL

Prepared for Gujarat NRE Coking Coal Limited

27 February 2013

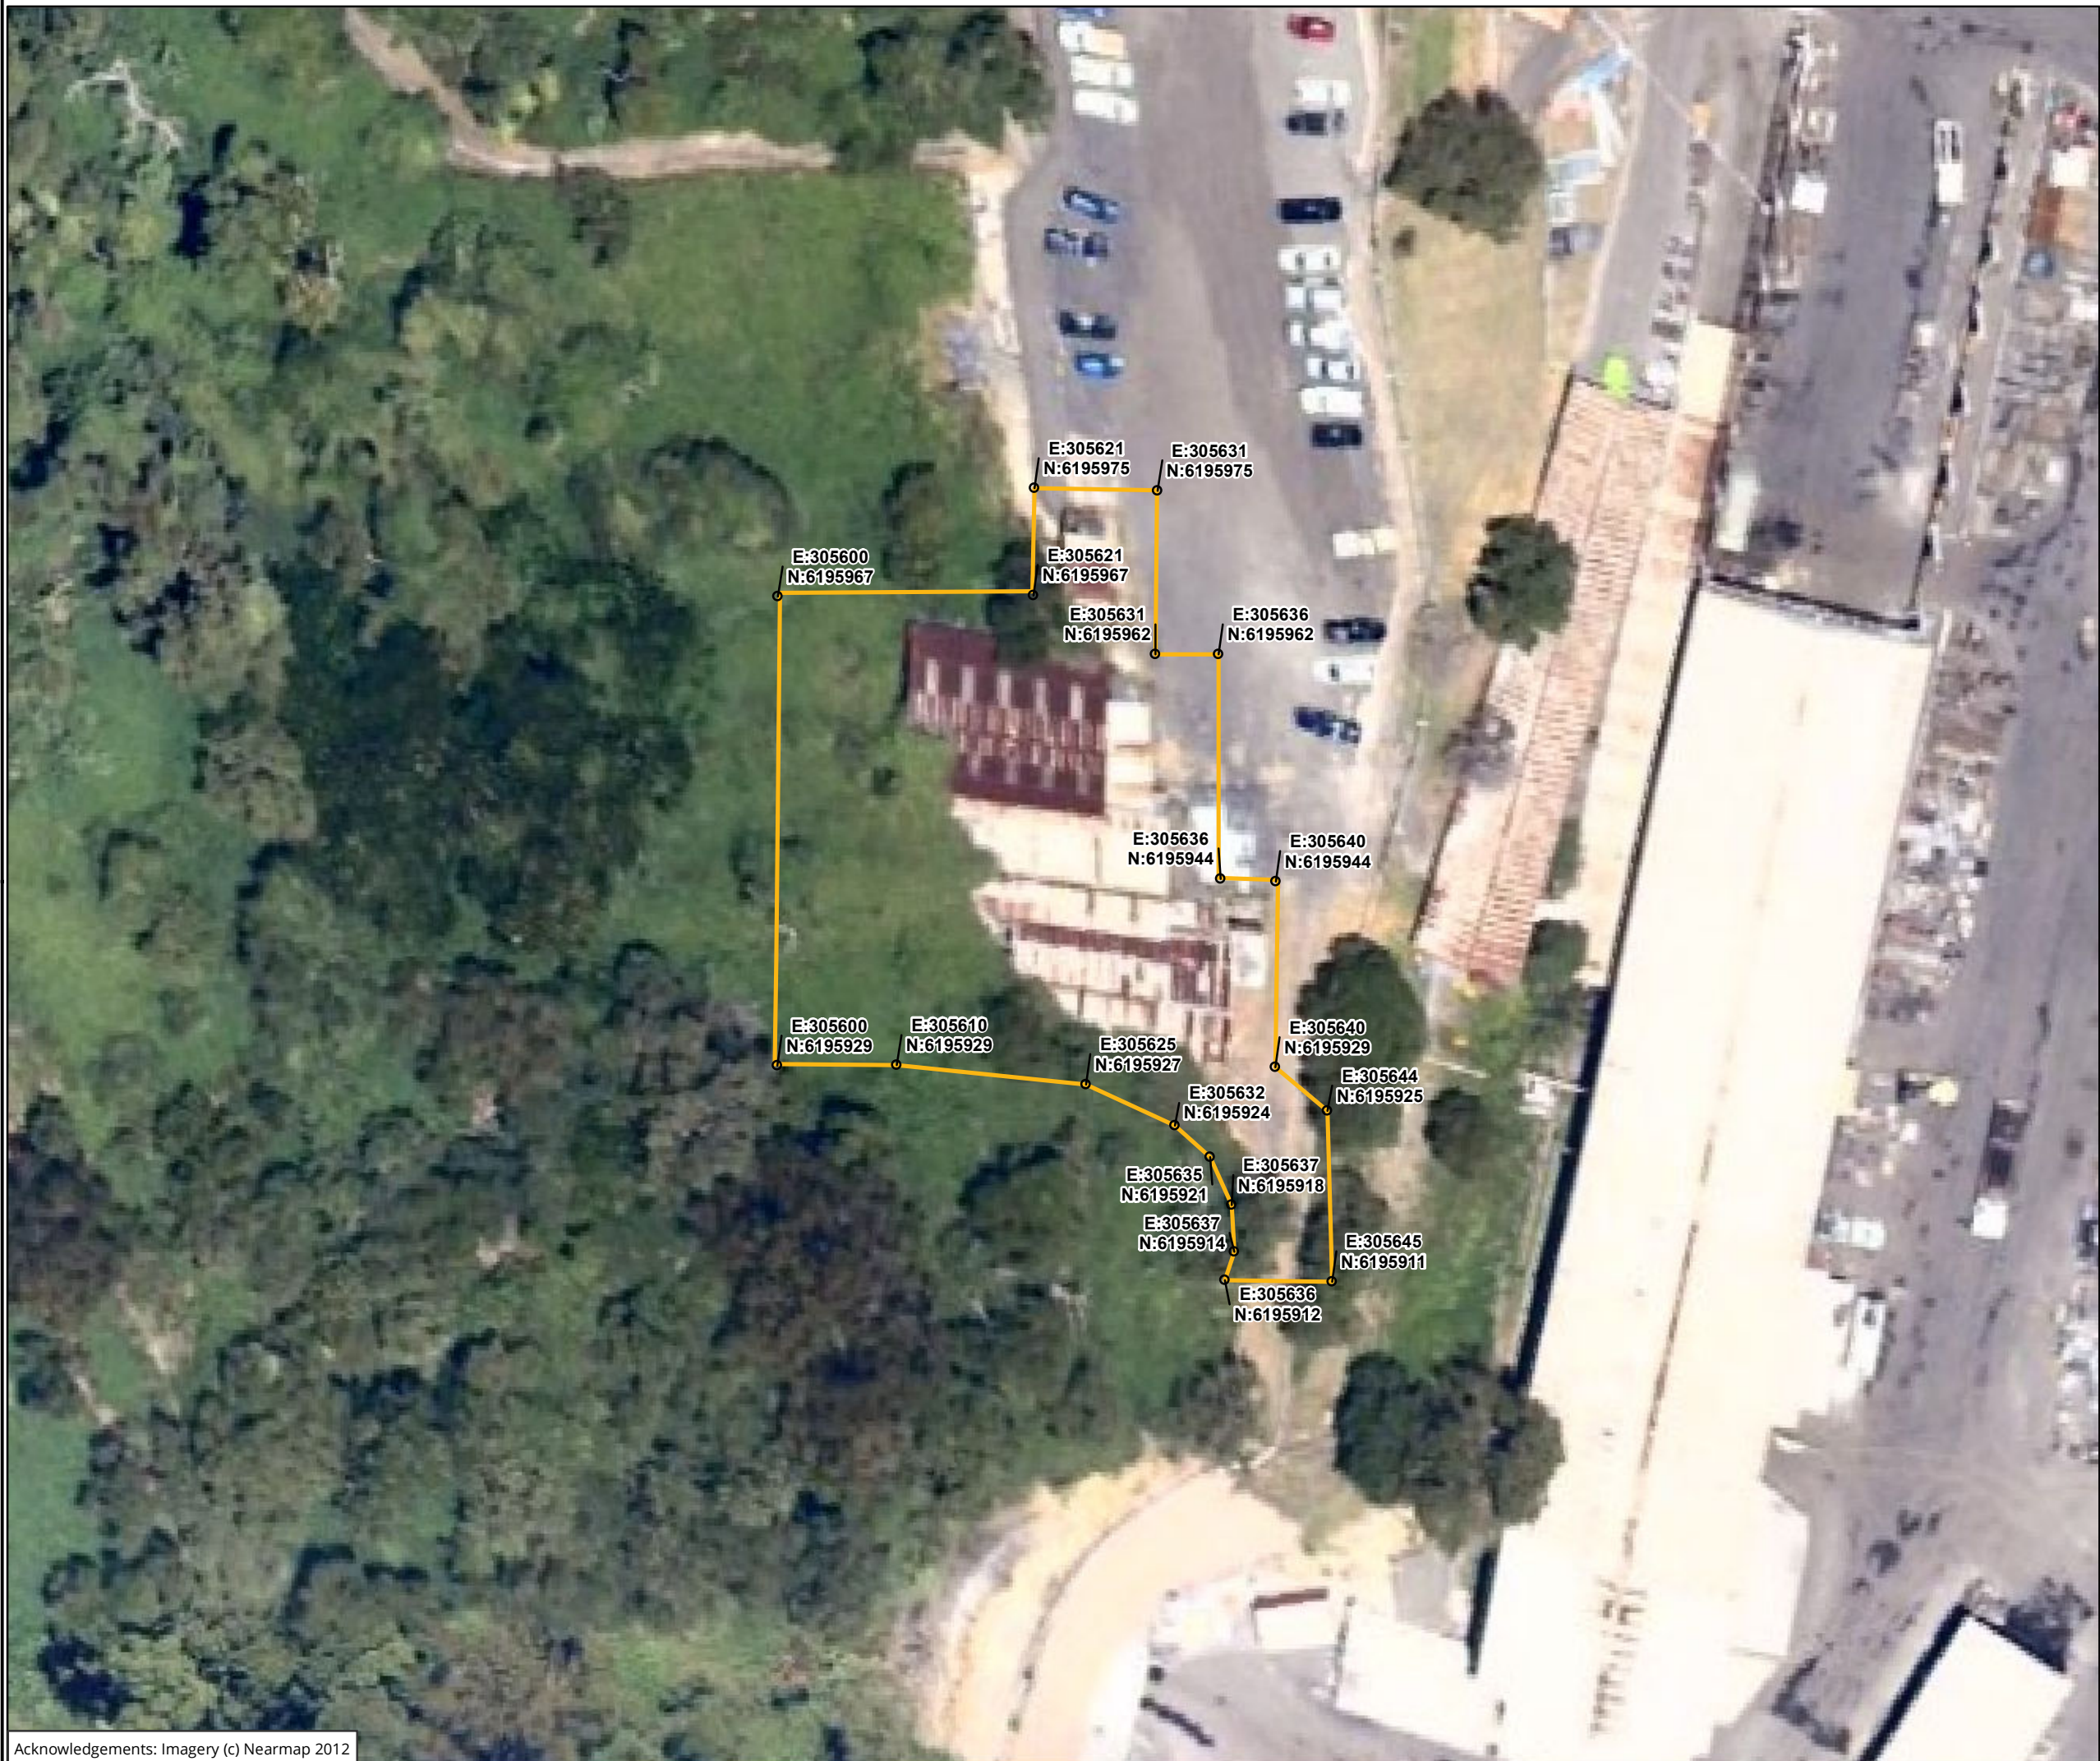
Figure 6: Old Portal Precinct Curtilage

The Old Portal Precinct curtilage is shown in Figure 6 and has been expanded from the 2004 GML curtilage to include the Upper Bench Workshop in its entirety. This curtilage includes the 1887 Portals, Brick Retaining Wall, Workshop Offices and associated Rail Infrastructure.

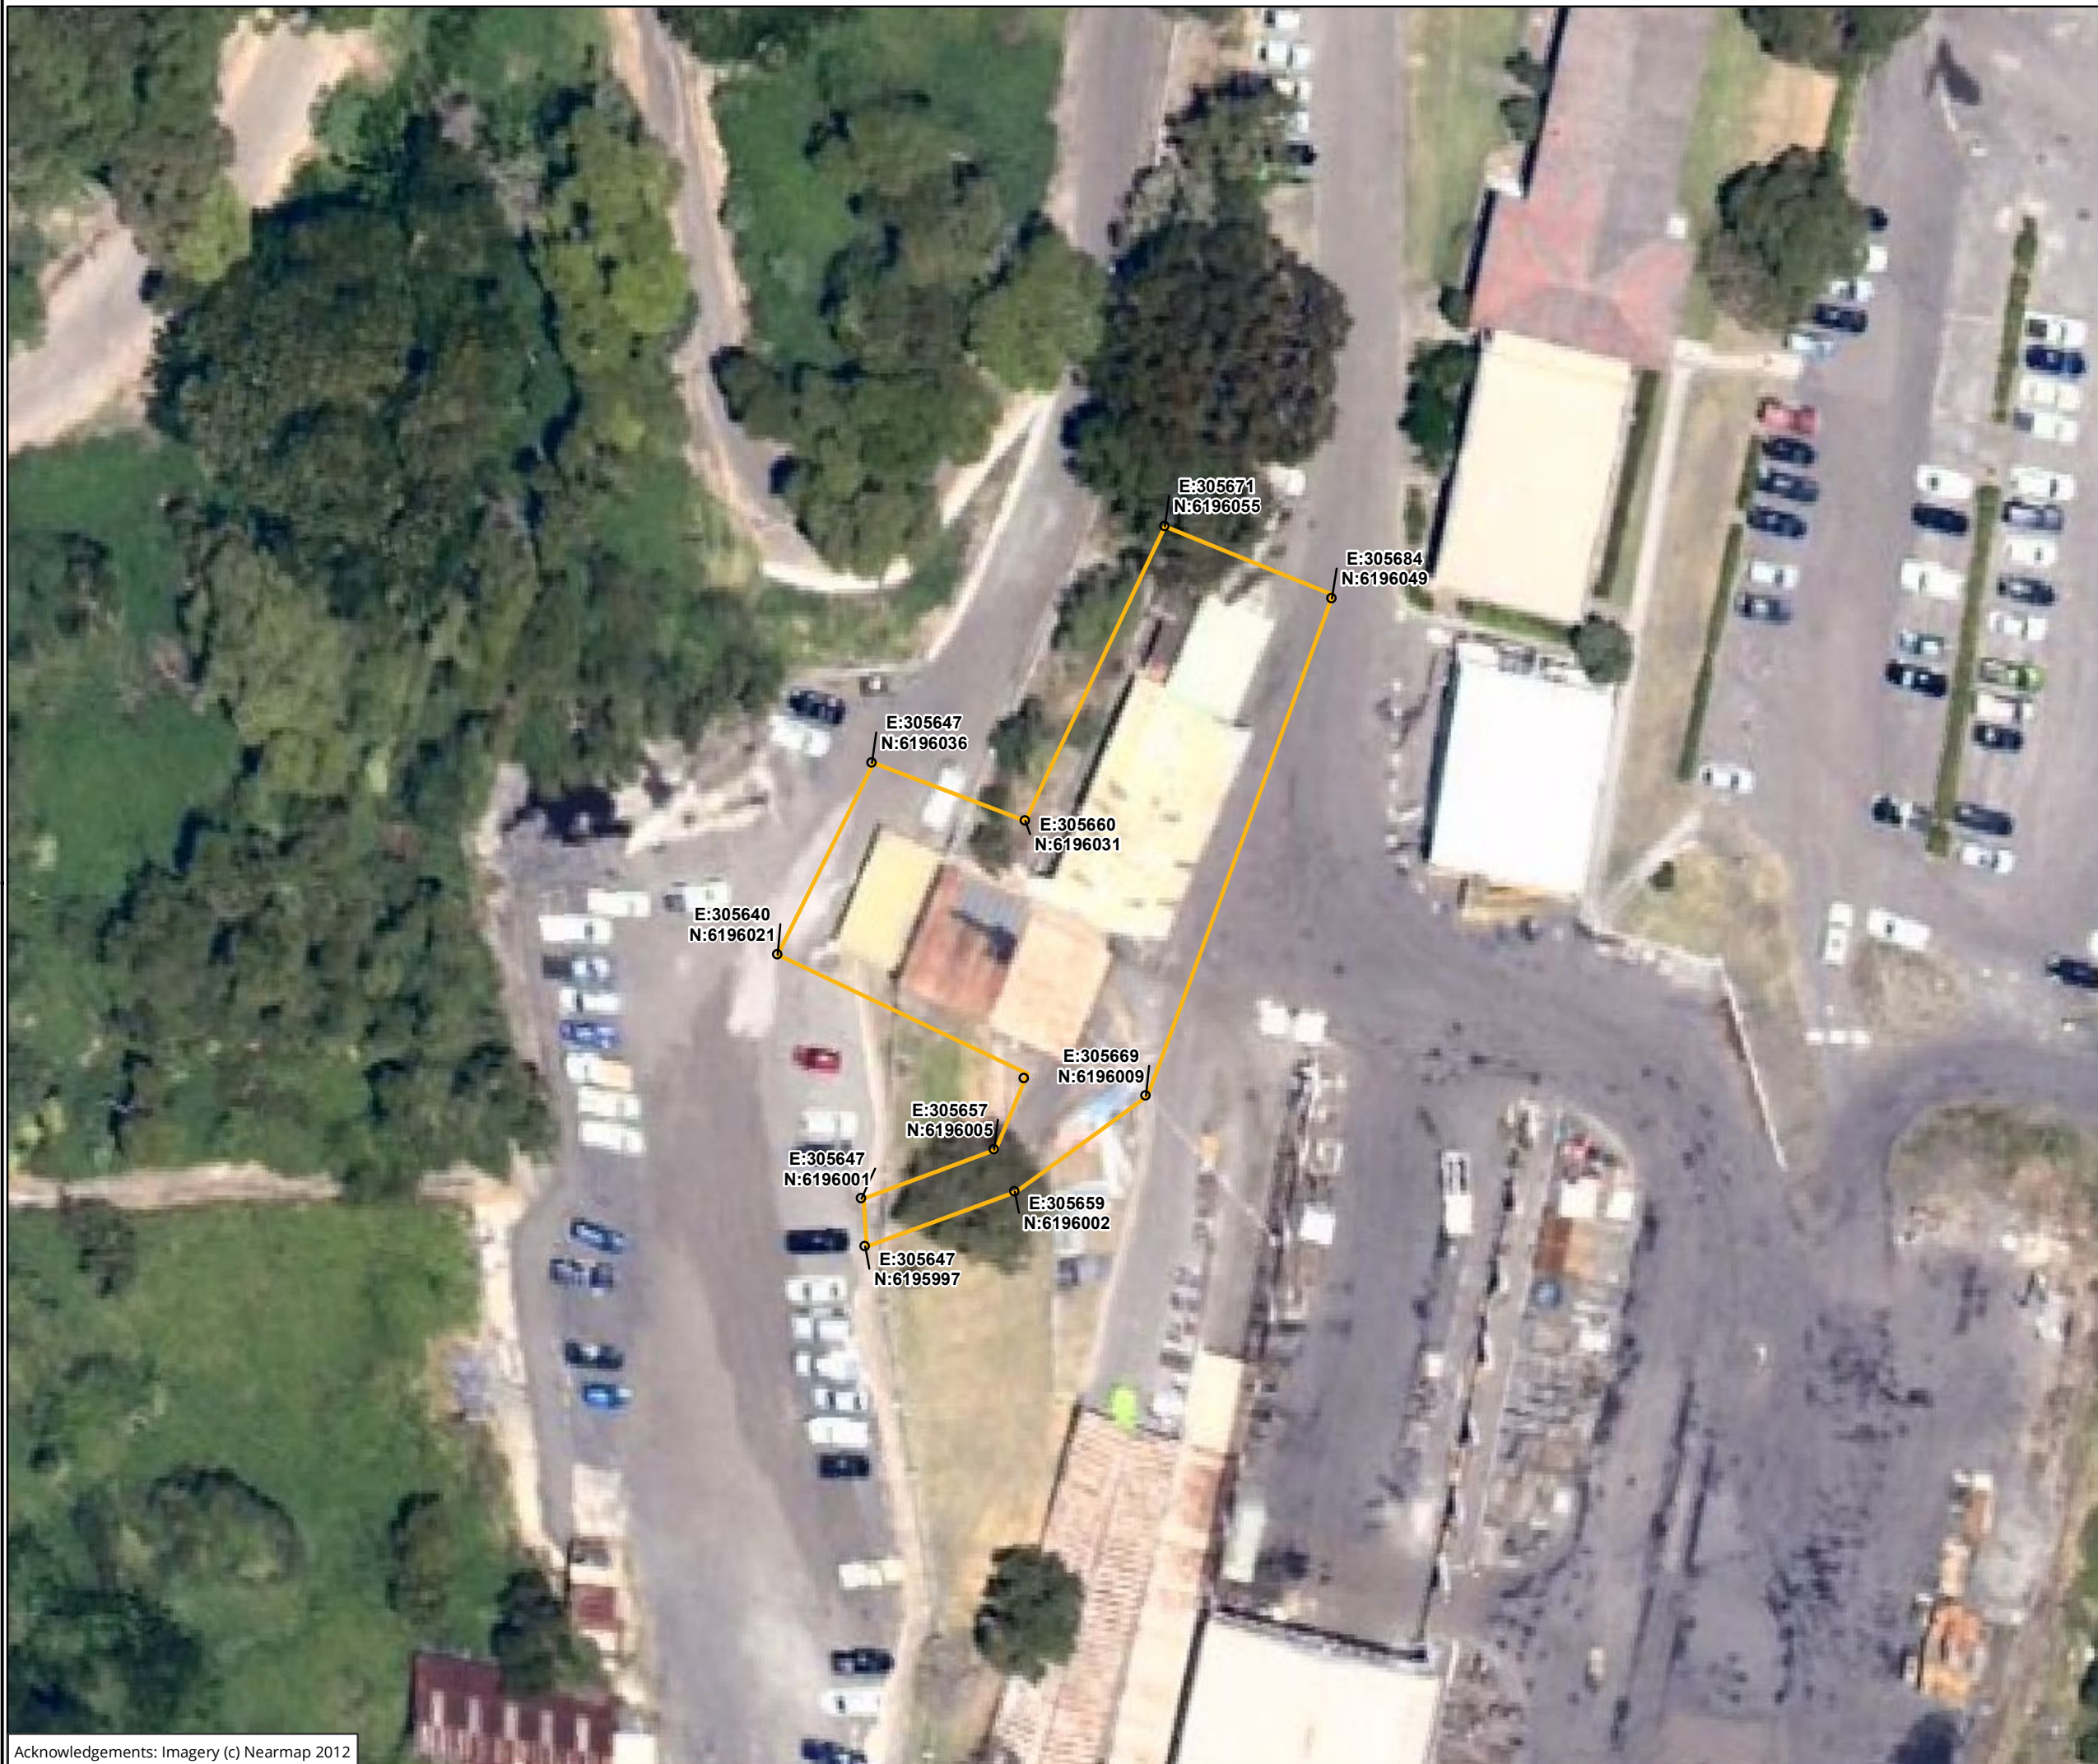
Figure 7: Main Portal Precinct Curtilage

The Main Portal Precinct curtilage is shown in Figure 7 and has been expanded from the 2004 GML curtilage to include the New Bathhouse. Other elements included in the curtilage include the Main Portal, Crib Room and First Aid Station and the Storeroom.

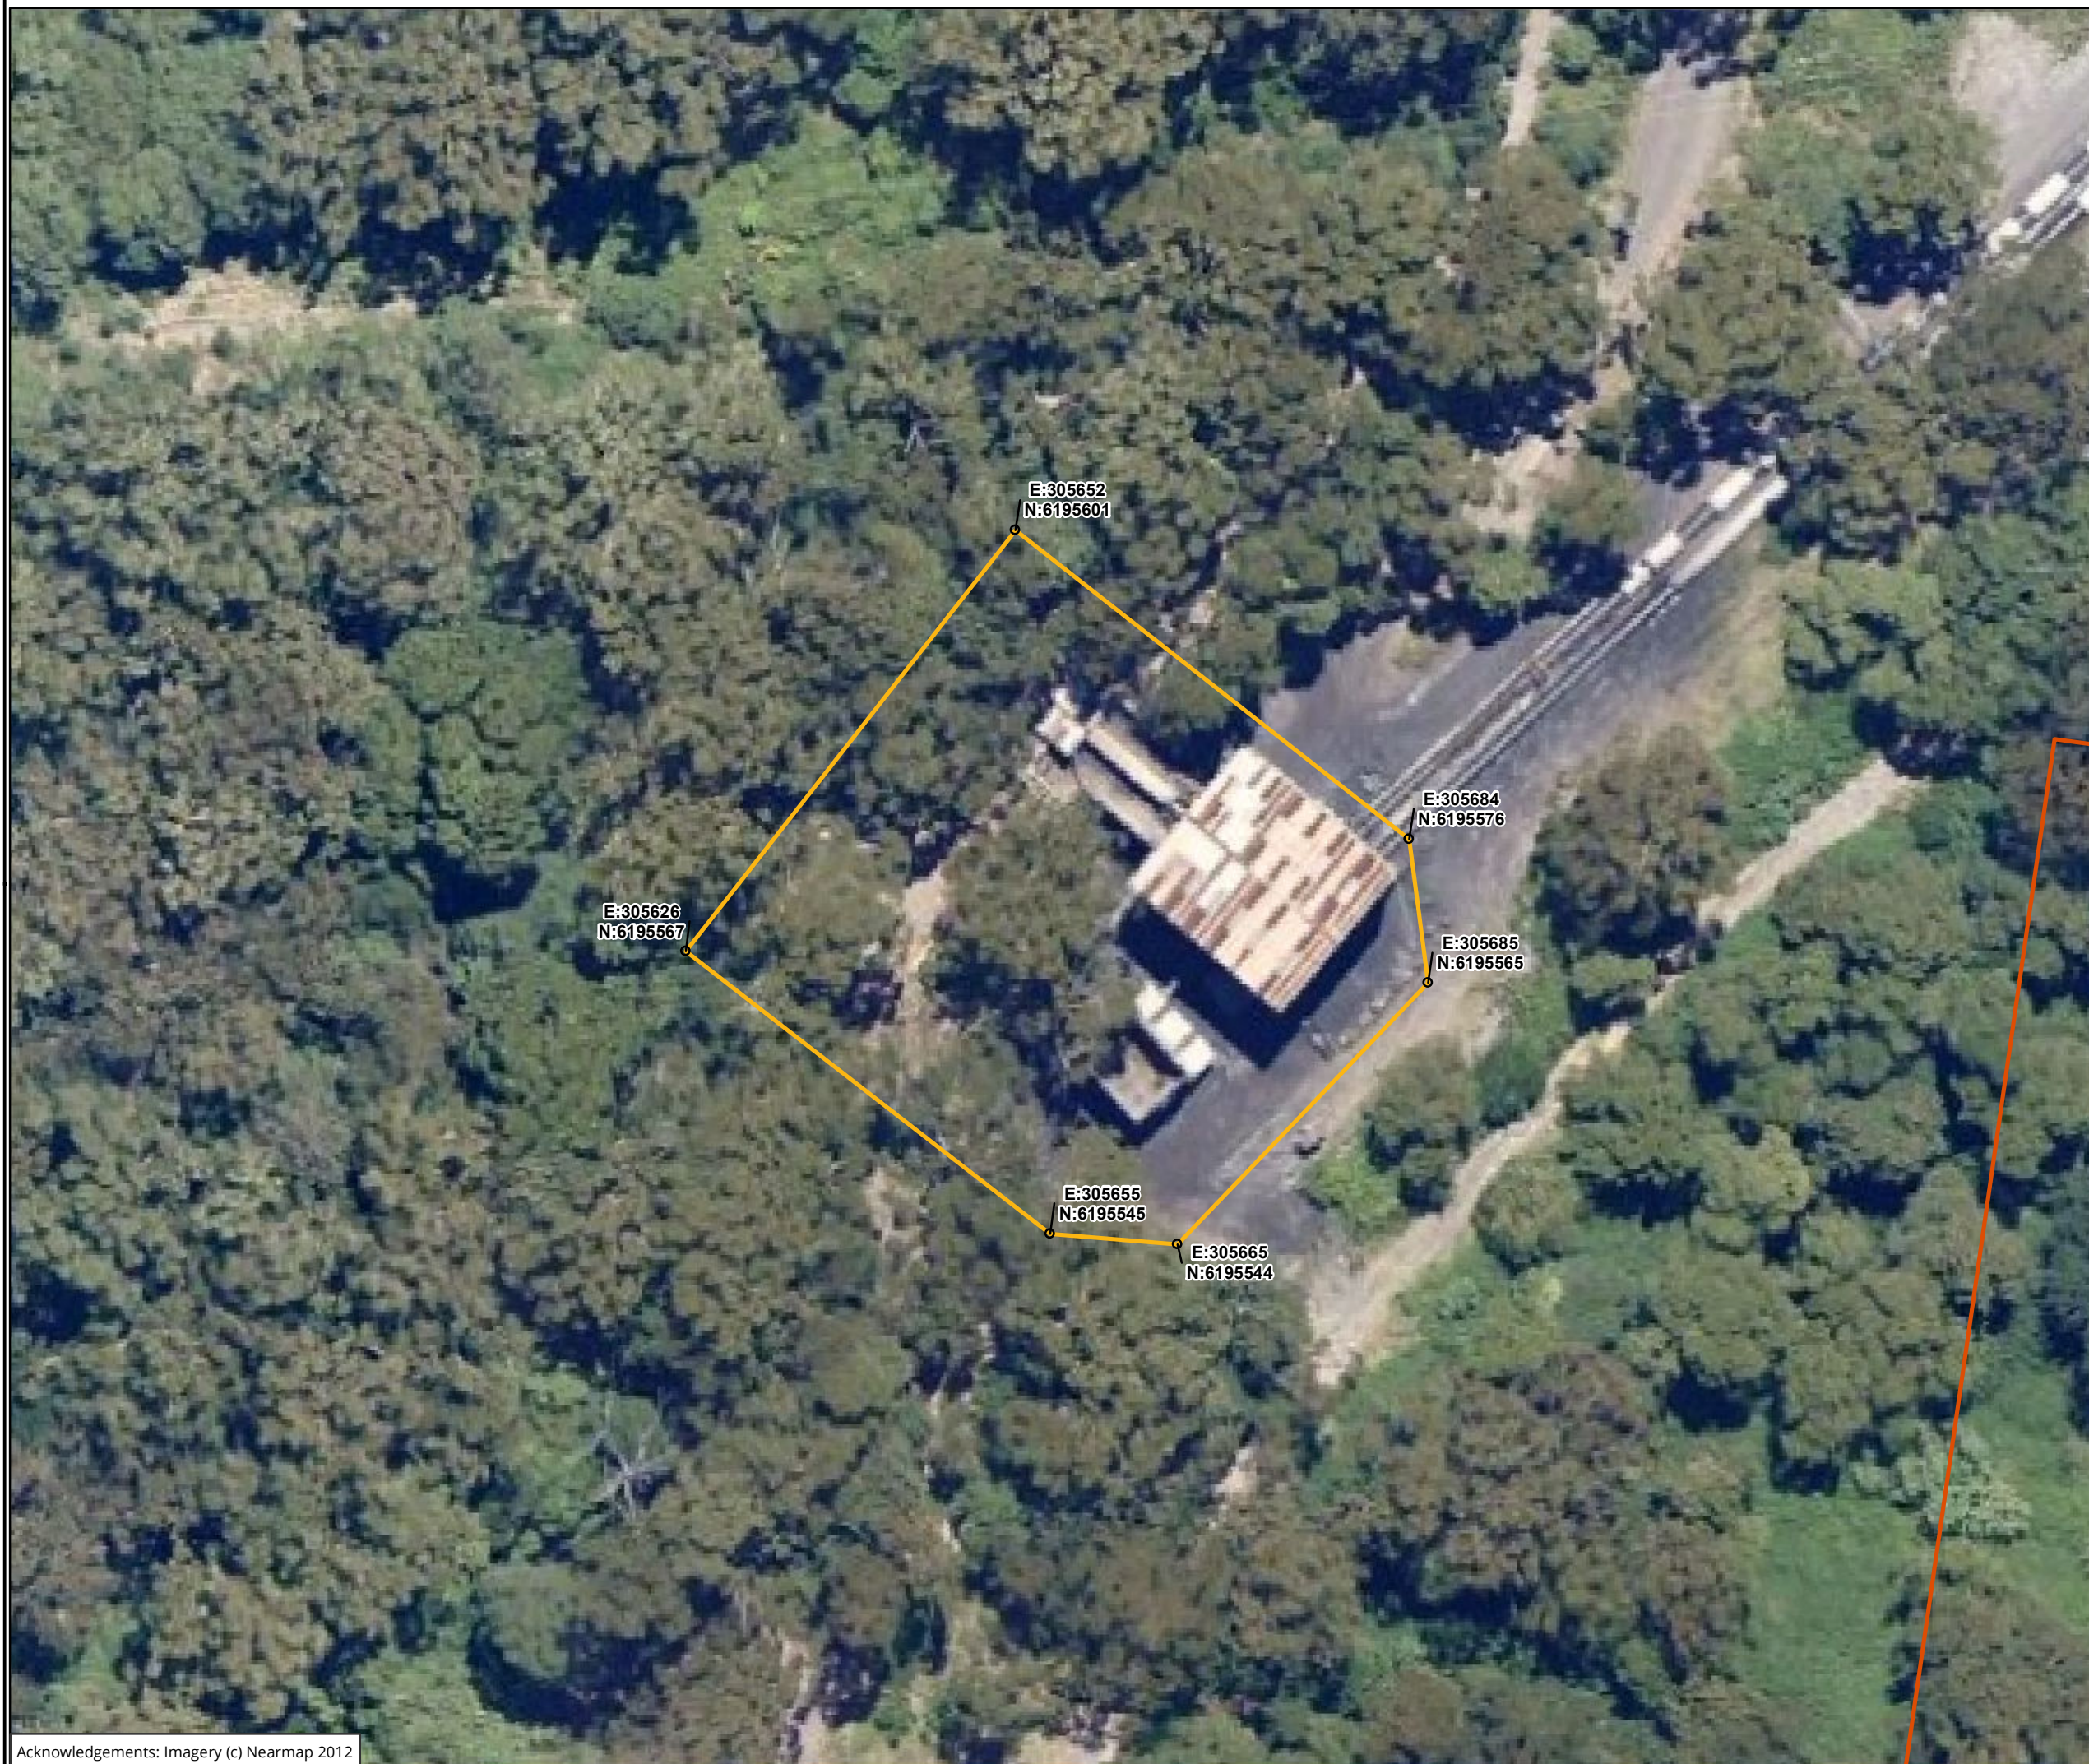
**Figure 8: Extraction Portal
Precinct Curtilage**

The Extraction Portal Precinct curtilage is shown in Figure 8 and has been expanded from three separate curtilages shown in the GML 2004 CMP to one overall curtilage. The Decline Conveyor has been excluded from the curtilage as it has little contributing significance.

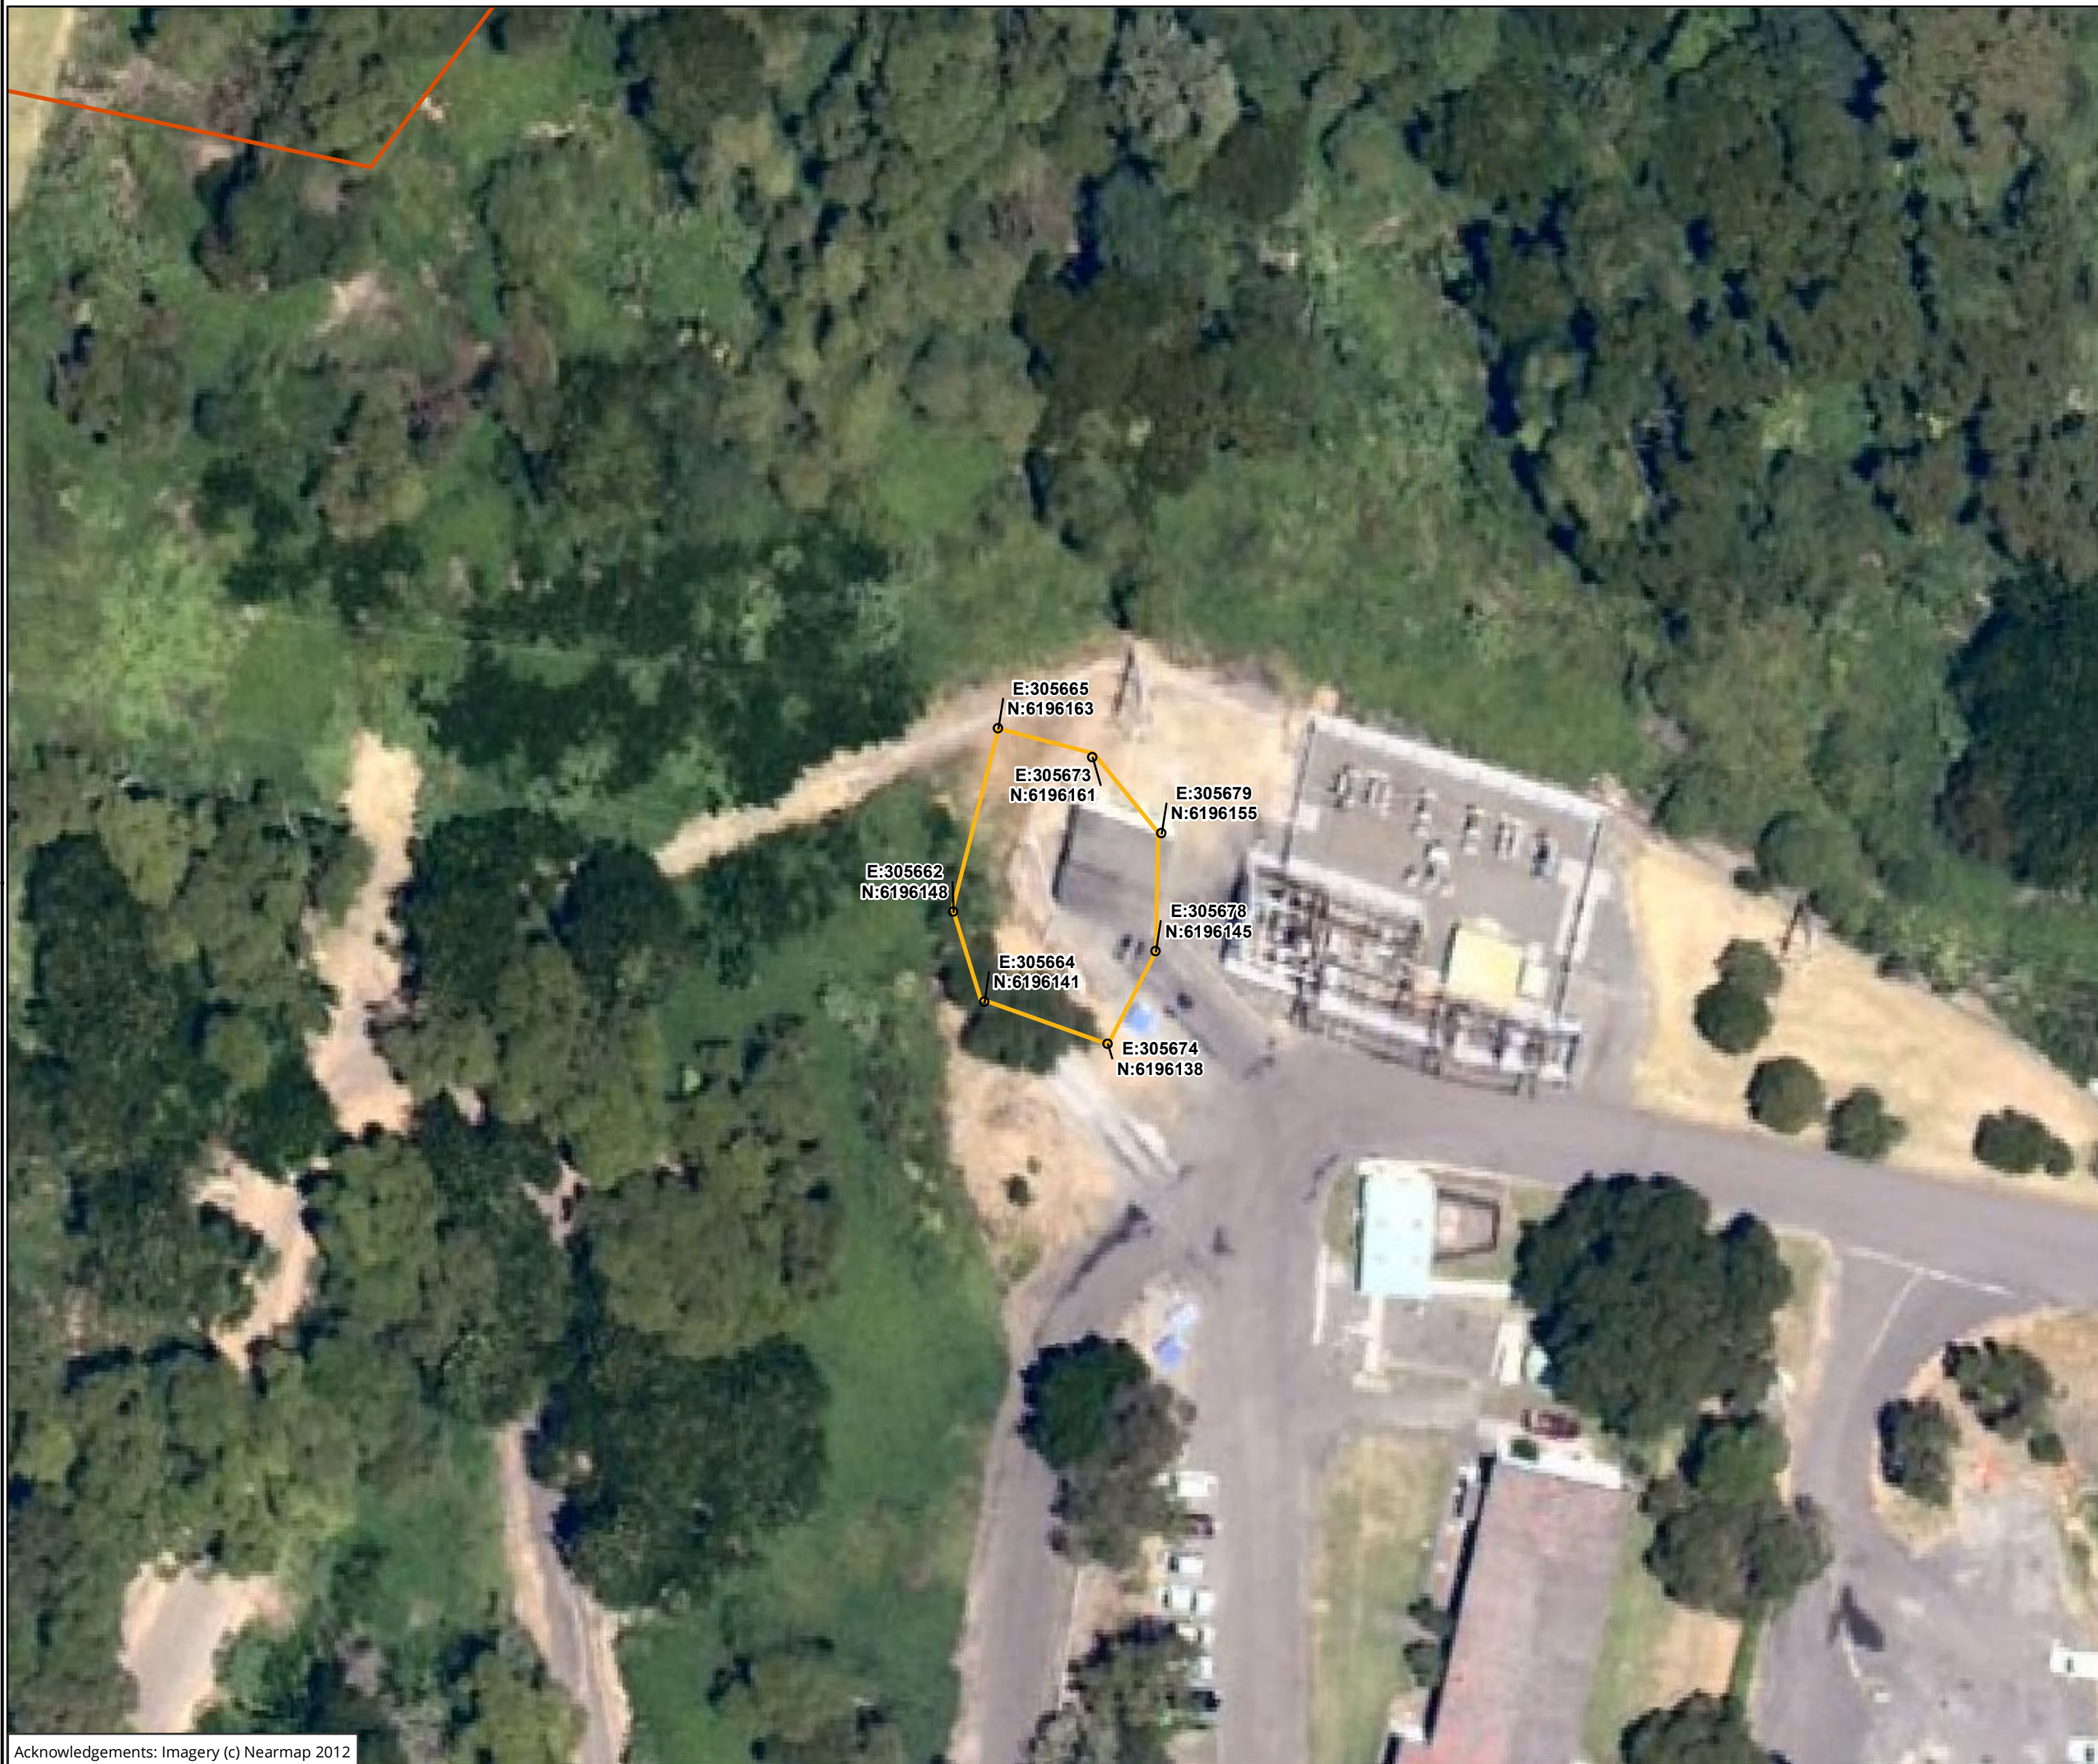
Figure 9: Gibson's Portal Curtilage

The Gibson's Portal Precinct curtilage is shown in Figure 9 and is not substantially changed from the 2004 GML curtilage, however the fan house has subsequently been removed.

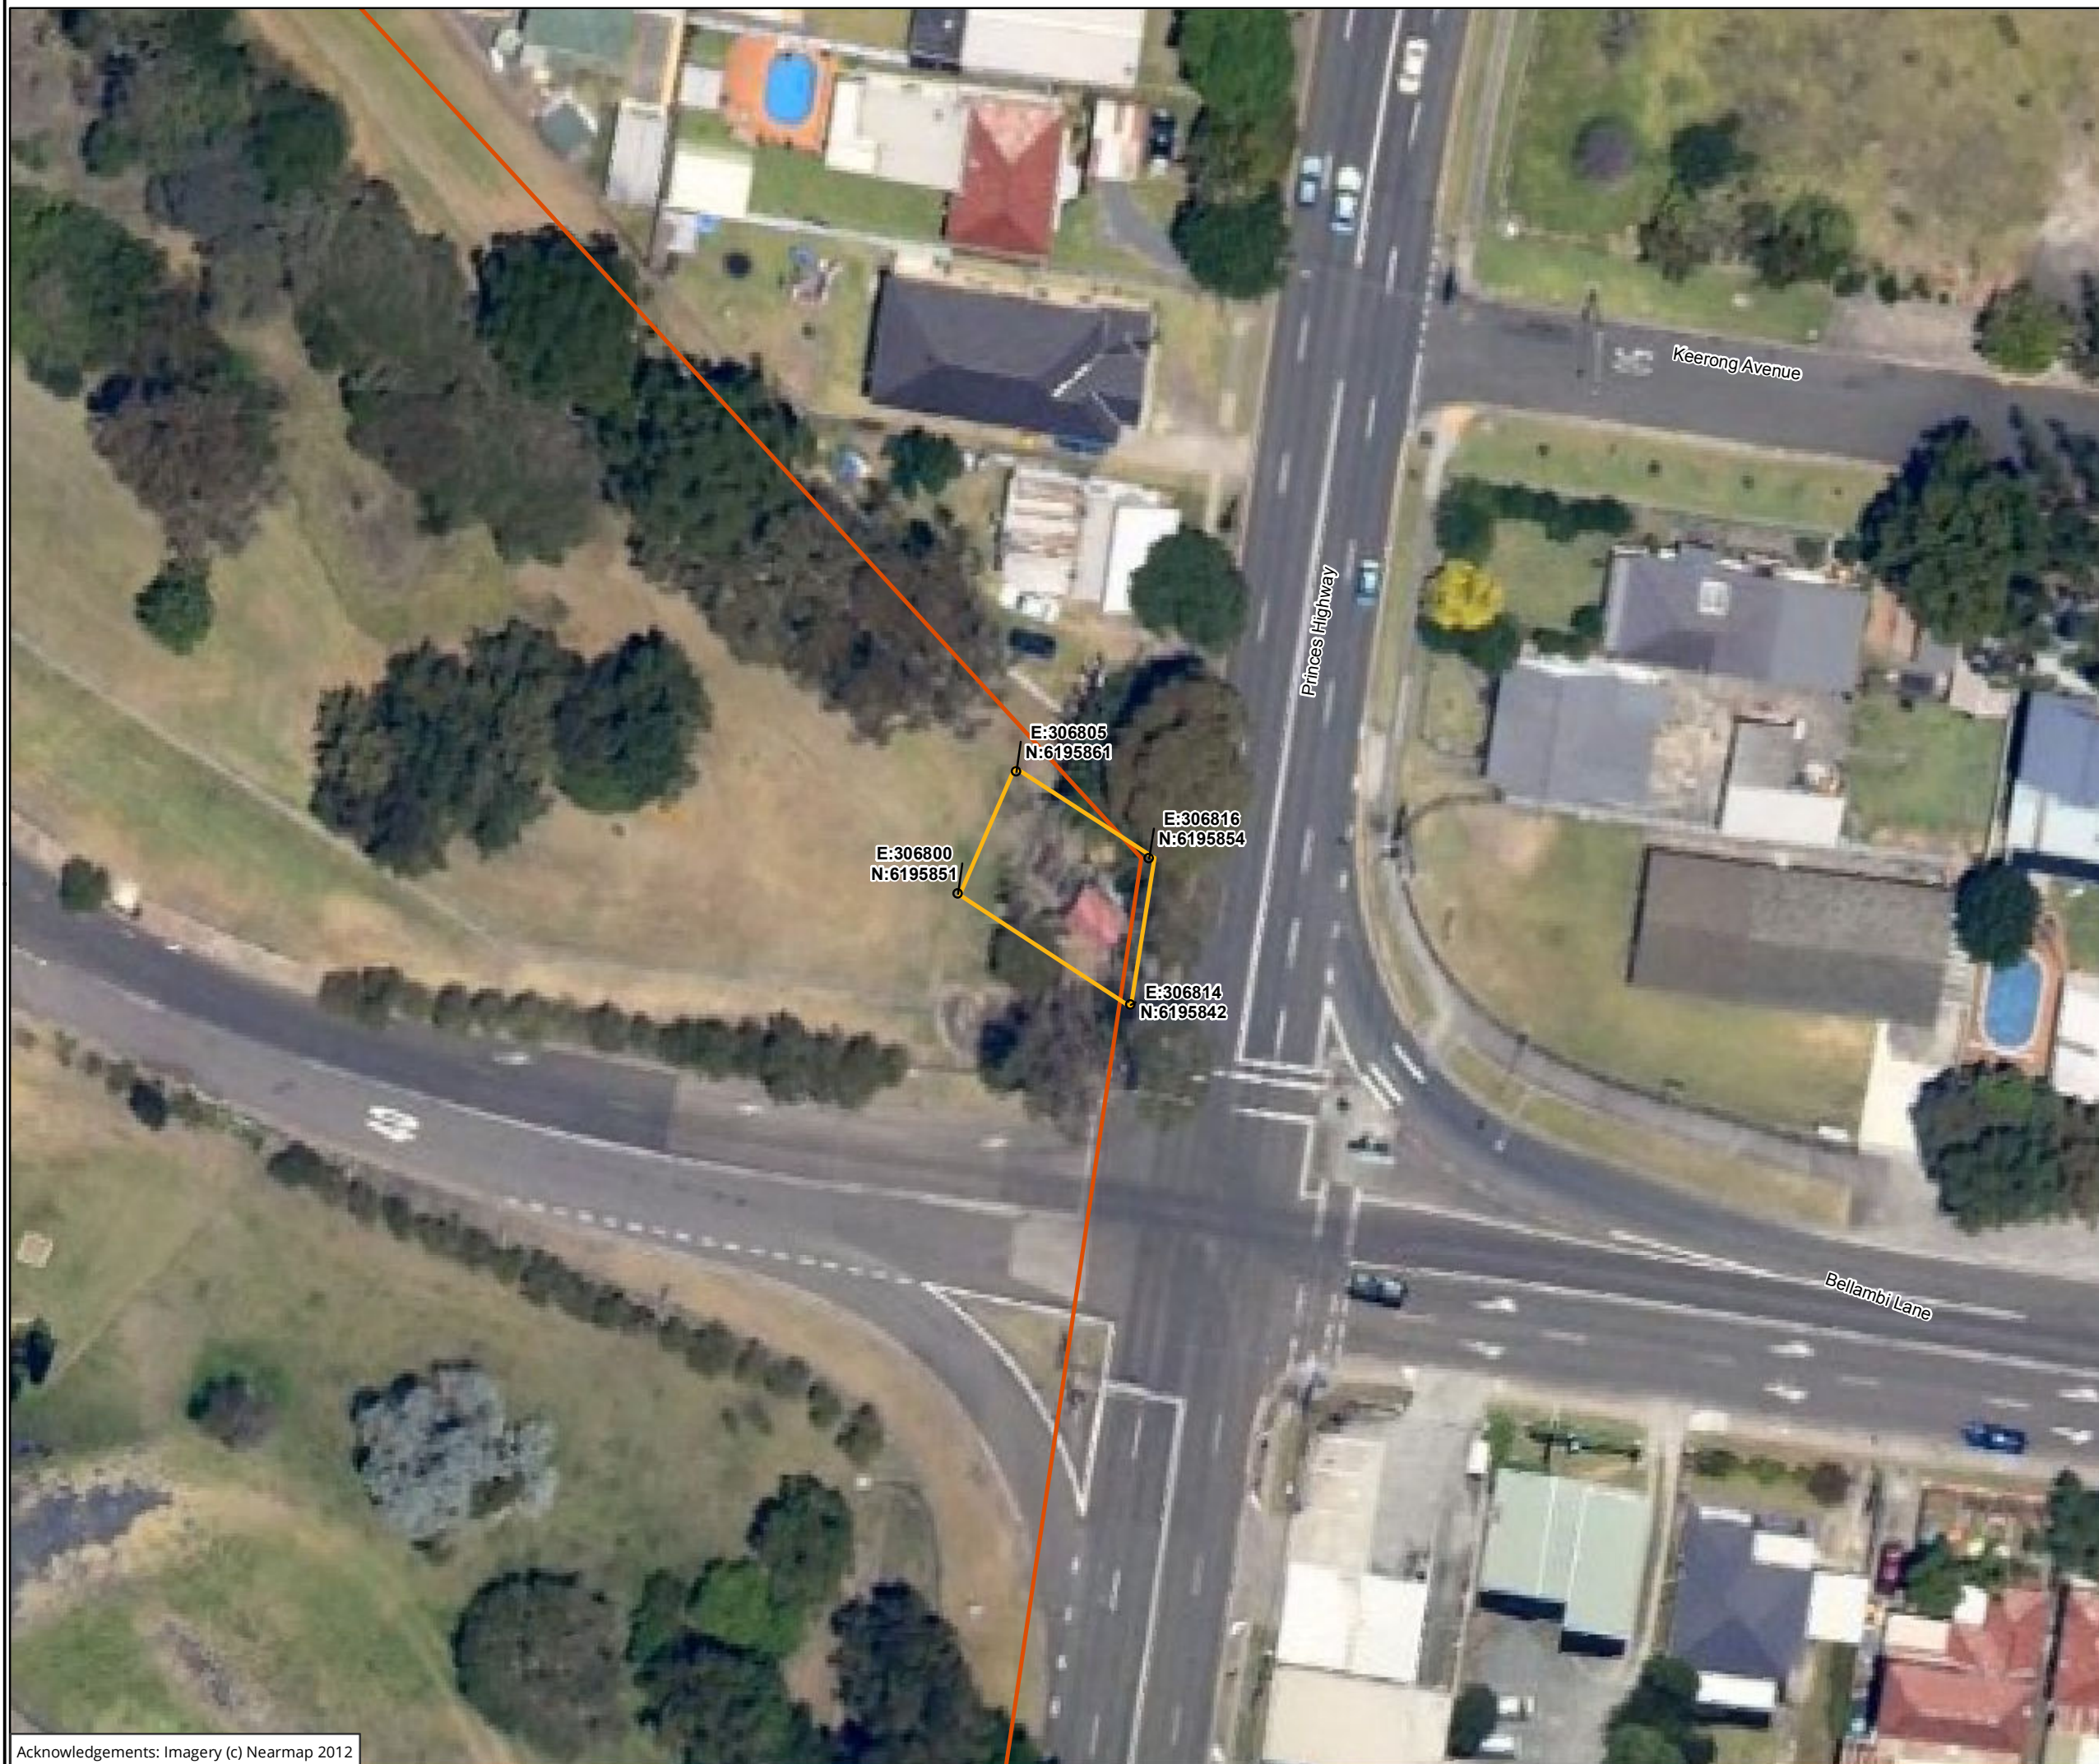
Figure 10: Signal Box Curtilage

The Signal Box curtilage is shown in Figure 10 and is not substantially changed from the 2004 GML curtilage.

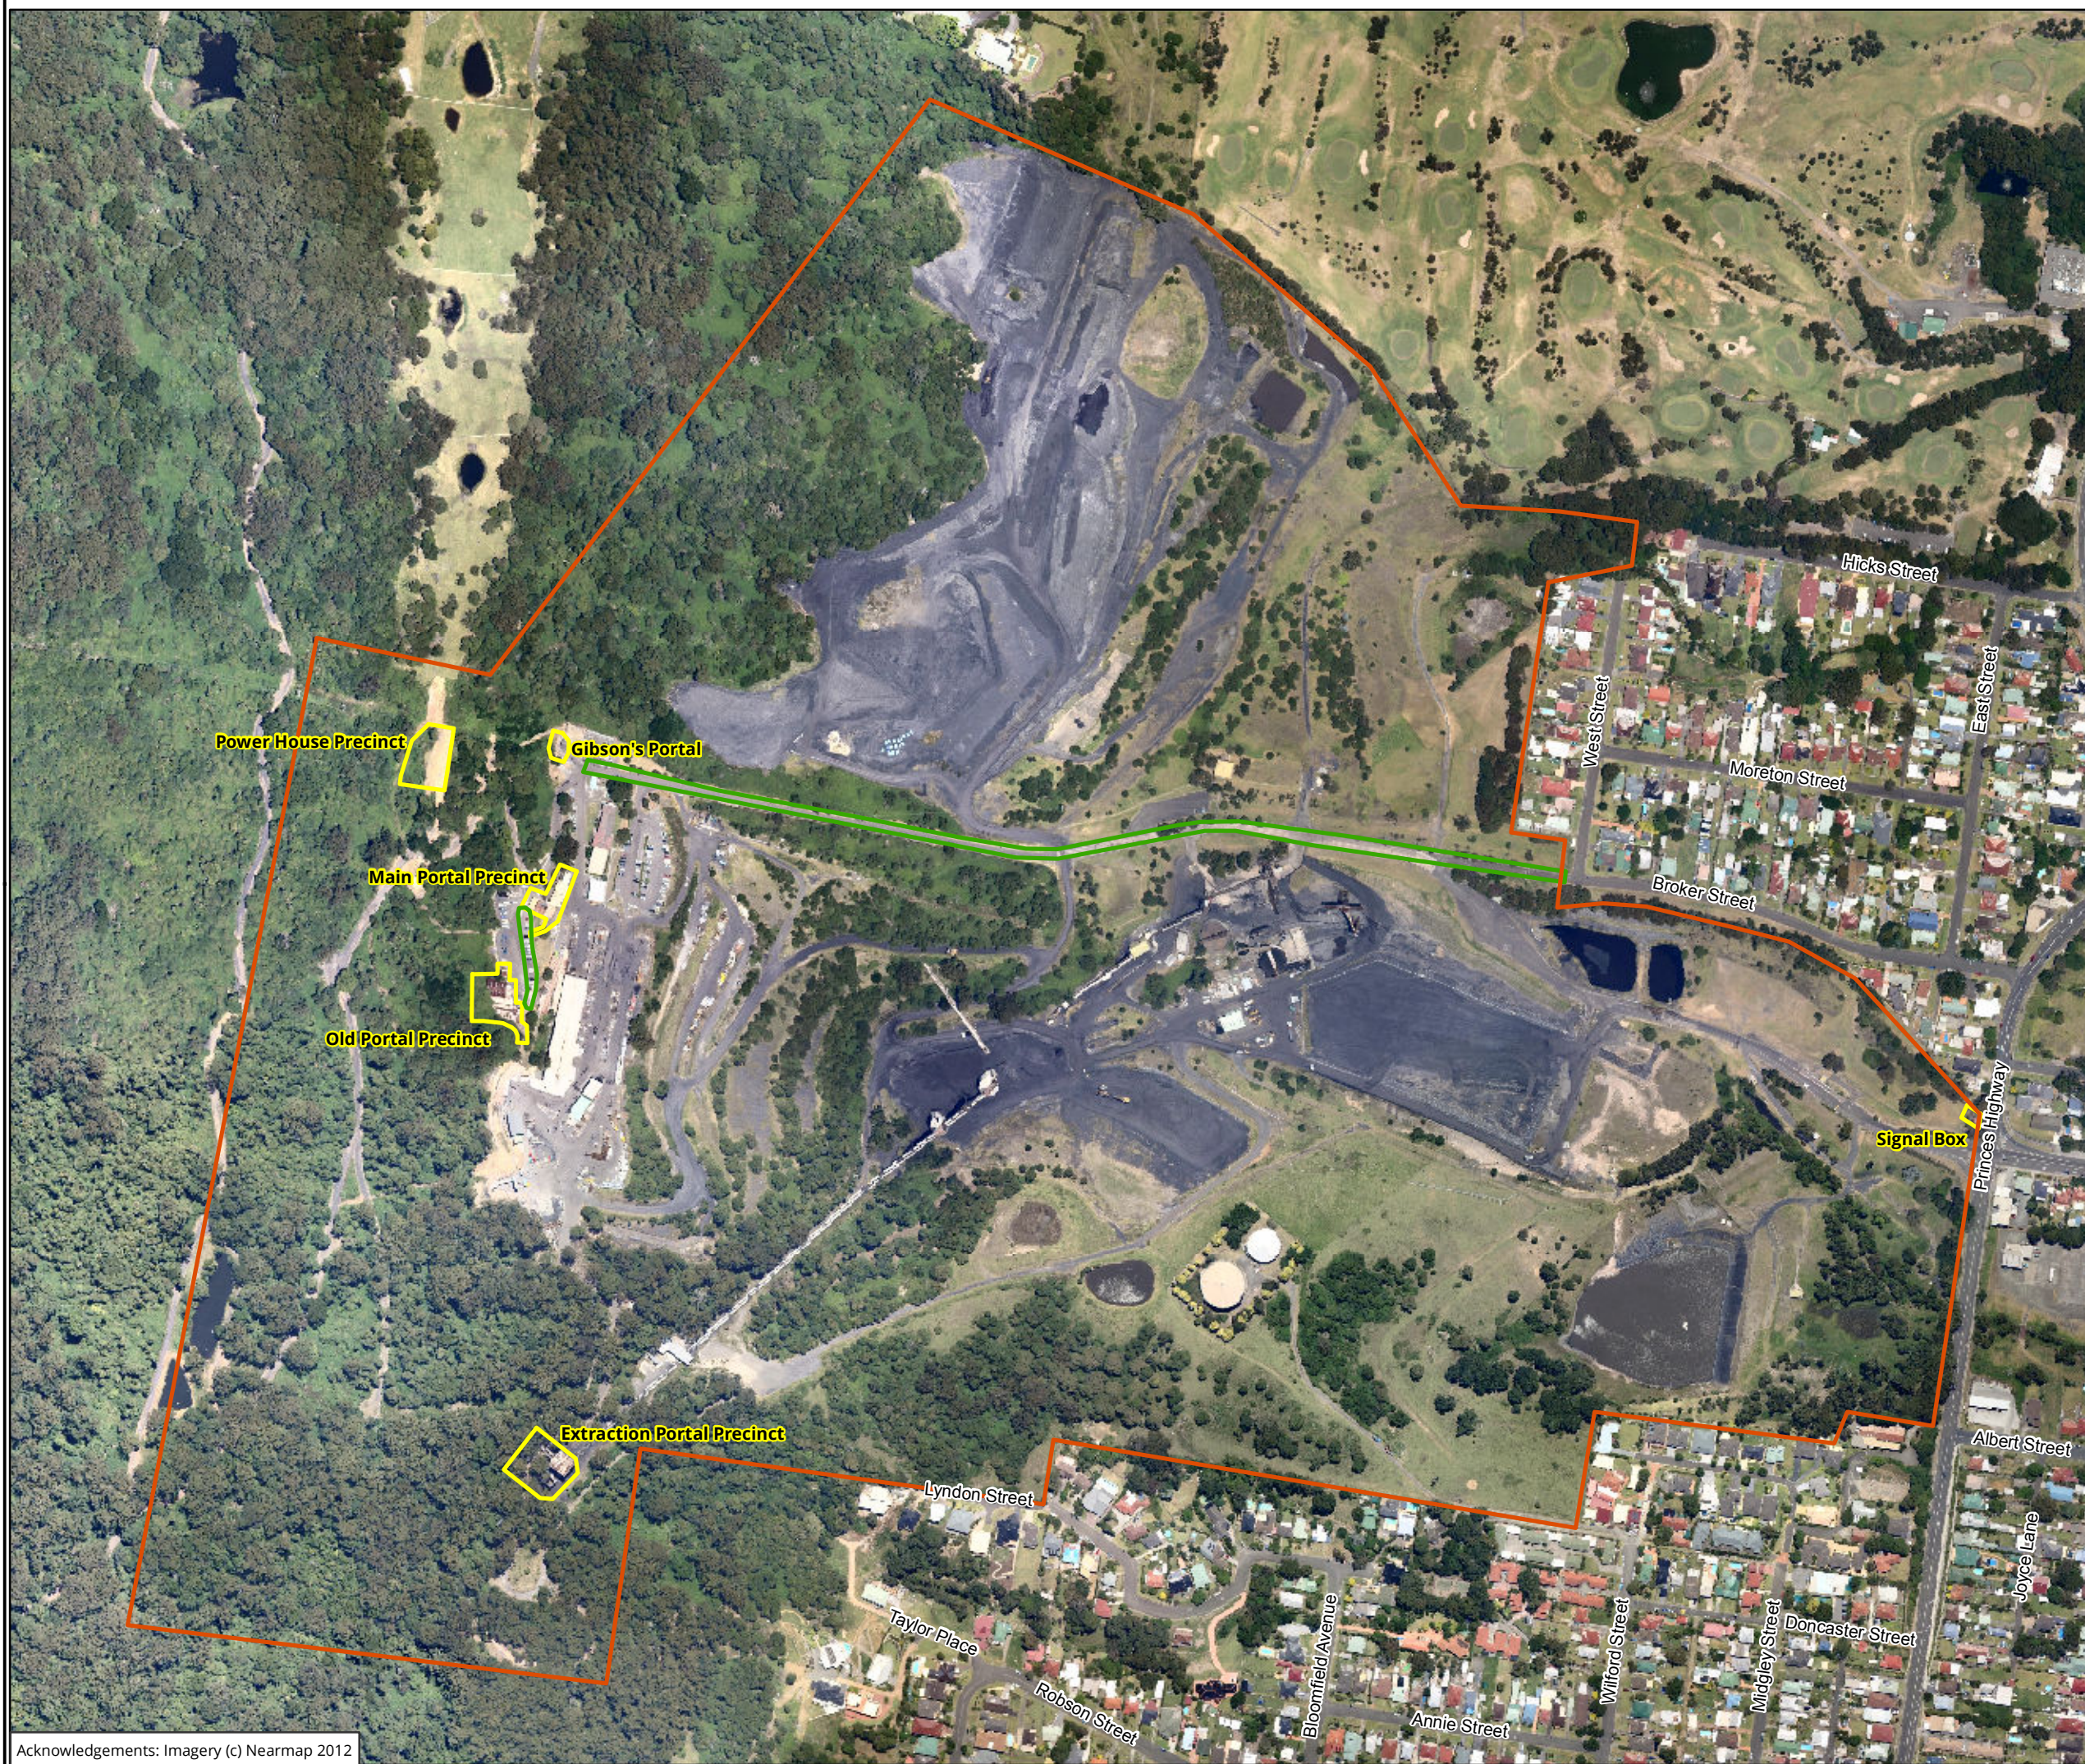
Figure 11: Landscape and Vistas

View lines are generally not critical, apart from that along the Remnant Incline Haulage Alignment, which has been identified in Figure 11.
